Demolition Asbestos Survey of:

Higher House Farm Buildings
Blackmoor Road
Blackburn

Report Reference:
JPR/AR/2007

Type of Asbestos Survey:		Demolition	
Report Status:		Final	
Report Reference:		JPR/AR/2007	
Report Requested By:		Growth & Development Department, Blackburn with Darwen Borough Council	
Surveyors Details		Signature	Date
Survey By:	John Robbie (Lead Surveyor) Mobile: 07989329656 Minimum Qualifications: BOHS: P402, P405, P406, S301 and over 15 years experience

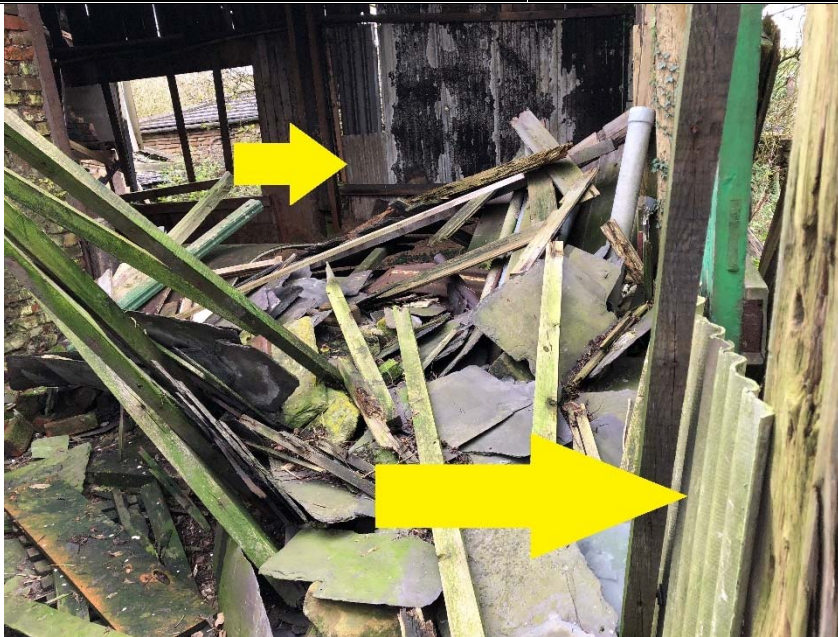
<p>4. Asbestos Survey Register (Survey Findings)</p>	BUILDING/ADDRESS: Higher House Farm Buildings, Blackamoor Road, Blackburn	DATE OF SURVEY: 31/10/2017	SURVEYED BY: J. Robbie – A. Robbie
	CLIENT: Growth & Development Department, Blackburn with Darwen Borough Council	JOB NO: JPR/AR/2007	ANALYSIS COMPANY: North Star Environmental Ltd
Floor Level/Location:	Ground floor		
Area Description:	Area logged as G08 & G10 (Refer to diagram)

Sample Number	Known Asbestos/1 (confirmed by the surveyor)	Material Risk Assessment (Refer to bottom of page for additional information)		
	Product/Material Description:	*Internal/External	Internal/external 1	
	Asbestos cement wall panels (Approx 2.5 Sqm). Further amounts of associated asbestos cement may be found within the general debris in the surrounding area	Product/Material	A/C 0	
		*Asbestos Type	Chrysotile (white) asbestos 1	
		*Condition	Poor condition 4	
		*Access	High access 2	
		*Treatment	Composite material 0	
		Quantity	Approx 2.5 Sqm	
			Total Points:	08
			Risk Assessment Category:	C

Recommendations/Comments:	Remove and dispose of as asbestos waste, prior to demolition. All works with asbestos must be undertaken in accordance with the current asbestos regulations (2012) and it's approved codes of practise.
Remediation/Management Comments:

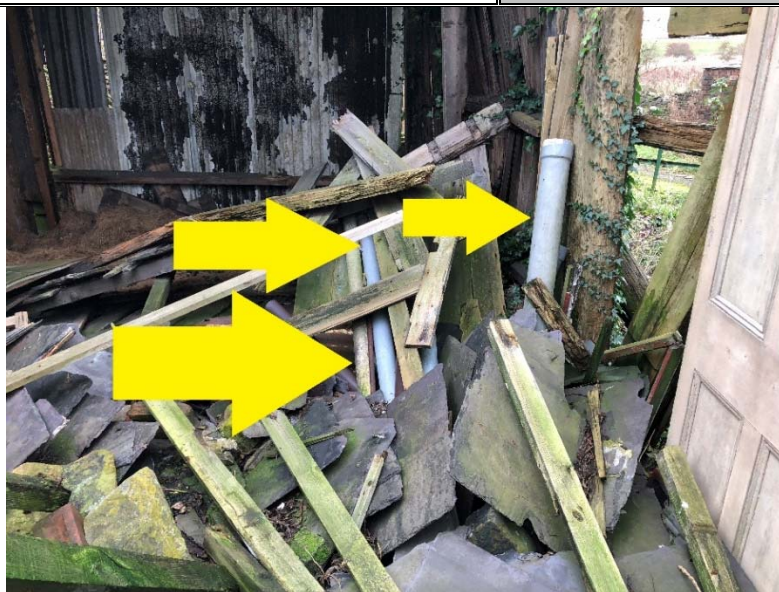
<p>4. Asbestos Survey Register (Survey Findings)</p>	BUILDING/ADDRESS: Higher House Farm Buildings, Blackamoor Road, Blackburn	DATE OF SURVEY: 31/10/2017	SURVEYED BY: J. Robbie – A. Robbie
	CLIENT: Growth & Development Department, Blackburn with Darwen Borough Council	JOB NO: JPR/AR/2007	ANALYSIS COMPANY: North Star Environmental Ltd
Floor Level/Location:	Ground floor		
Area Description:	Area logged as G08/G10 (Refer to diagram)

Sample Number	Known Asbestos/2 (confirmed by the surveyor)	Material Risk Assessment (Refer to bottom of page for additional information)		
	Product/Material Description:	*Internal/External	Internal/external	
	Asbestos cement tubes, mixed in with general rubble/debris (full extent unknown)	Product/Material	A/C	
		*Asbestos Type	Chrysotile (white) asbestos	
		*Condition	Poor condition	
		*Access	High access	
		*Treatment	Composite material	
		Quantity	Full extent unknown, mixed with general rubbish	
		Total Points:		08
		Risk Assessment Category:		C

Recommendations/Comments:	Remove and dispose of as asbestos waste, prior to demolition. All works with asbestos must be undertaken in accordance with the current asbestos regulations (2012) and it's approved codes of practise.
Remediation/Management Comments:

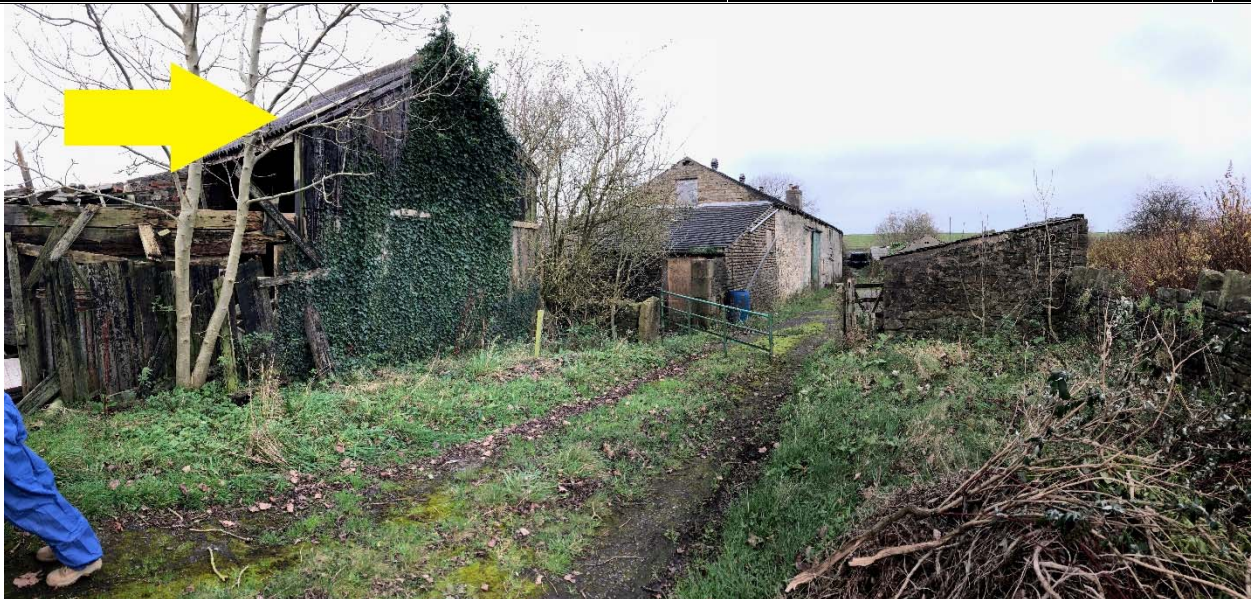
<p>4. Asbestos Survey Register (Survey Findings)</p>	BUILDING/ADDRESS: Higher House Farm Buildings, Blackamoor Road, Blackburn	DATE OF SURVEY: 31/10/2017	SURVEYED BY: J. Robbie – A. Robbie
	CLIENT: Growth & Development Department, Blackburn with Darwen Borough Council	JOB NO: JPR/AR/2007	ANALYSIS COMPANY: North Star Environmental Ltd
Floor Level/Location:	Ground floor		
Area Description:	Area logged as G10 (Refer to diagram)

Sample Number	Known Asbestos/3 (confirmed by the surveyor)	Material Risk Assessment (Refer to bottom of page for additional information)		
	Product/Material Description:	*Internal/External	Internal/external	1
	Asbestos cement corrugated roof sheets	Product/Material	A/C	0
		*Asbestos Type	Chrysotile (white) asbestos	1
		*Condition	Medium condition	2
		*Access	Limited access	0
		*Treatment	Composite material	0
		Quantity	Approx 75 Sqm	
			Total Points:	04
			Risk Assessment Category:	D

Recommendations/Comments:	Remove and dispose of as asbestos waste, prior to demolition. All works with asbestos must be undertaken in accordance with the current asbestos regulations (2012) and it's approved codes of practise.
Remediation/Management Comments:

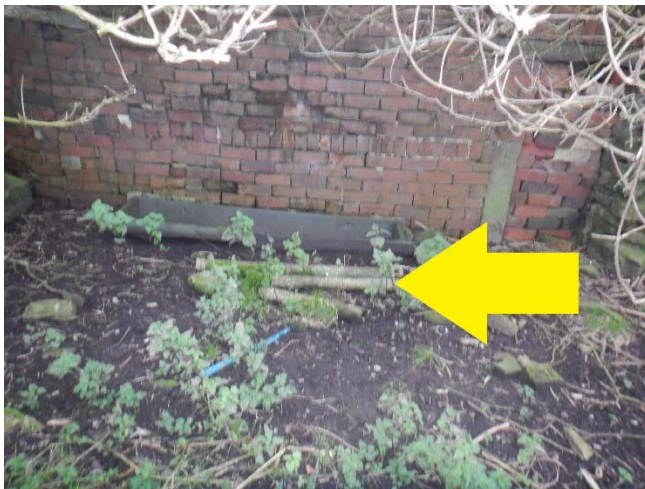
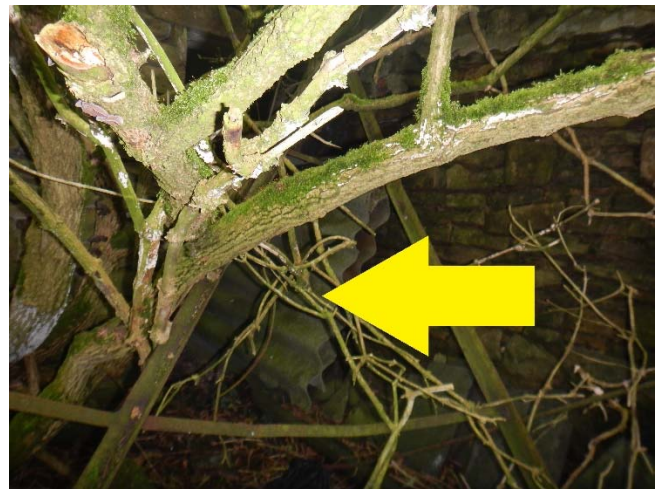
Known Asbestos/4 (confirmed by surveyor)	External	Area logged as G13, and outside of G13 (Refer to diagram)	Loose asbestos cement corrugated sheets and A/C tubes to the external ground	C	Remove/dispose of as asbestos waste
Sample FB/11	External	Area logged as G30	Asbestos cement (A/C) roof sheets	D	Remove/dispose of as asbestos waste
Known Asbestos/5 (confirmed by surveyor)	Internal	Room logged as G31	Asbestos containing W/C cistern	D	Remove/dispose of as asbestos waste
As Sample FB/13(2)	External	Area logged as G35	Loose asbestos (A/C) cement sheets and an A/C tube to the ground (Approx 4 Sqm)	C	Remove/dispose of as asbestos waste
As Sample FB/13(3)	External	Area logged as G35	Asbestos cement (A/C) fascia (Approx 6 Sqm)	D	Remove/dispose of as asbestos waste
As Sample FB/13(1)	External	Area logged as G36 / G37	Asbestos cement (A/C) roof sheet debris, mixed in with general debris/overgrowth. The A/C debris is thought to have been the roof of the structure (Approx 20 Sqm)	C	Remove/dispose of as asbestos waste

<p>4. Asbestos Survey Register (Survey Findings)</p>	BUILDING/ADDRESS: Higher House Farm Buildings, Blackamoor Road, Blackburn	DATE OF SURVEY: 31/10/2017	SURVEYED BY: J. Robbie – A. Robbie
	CLIENT: Growth & Development Department, Blackburn with Darwen Borough Council	JOB NO: JPR/AR/2007	ANALYSIS COMPANY: North Star Environmental Ltd
Floor Level/Location:	Ground floor		
Area Description:	Area logged as G13, also external to G13 (Refer to diagram)

Sample Number	Known Asbestos/4 (confirmed by the surveyor)	Material Risk Assessment (Refer to bottom of page for additional information)		
	Product/Material Description:	*Internal/External	Internal/external	
	Loose asbestos cement corrugated sheets and A/C tubes to the external ground		1	
		Product/Material	A/C	0
		*Asbestos Type	Chrysotile (white) asbestos	1
		*Condition	Poor condition	4
		*Access	High/limited access	1
		*Treatment	Composite material	0
		Quantity	Full extent unknown, cant access G13	
			Total Points:	08
		Risk Assessment Category:	C

Recommendations/Comments:	Remove and dispose of as asbestos waste, prior to demolition. All works with asbestos must be undertaken in accordance with the current asbestos regulations (2012) and it's approved codes of practise.
Remediation/Management Comments:

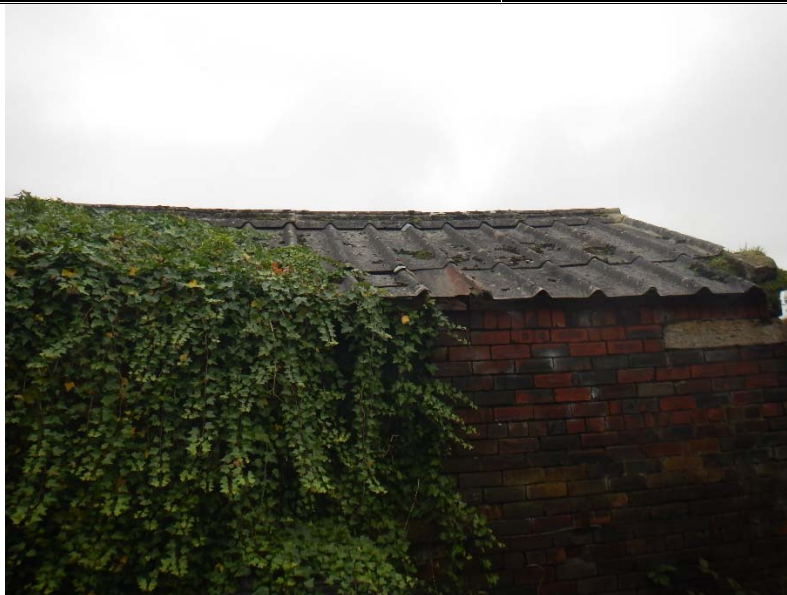
<p>4. Asbestos Survey Register (Survey Findings)</p>	BUILDING/ADDRESS: Higher House Farm Buildings, Blackamoor Road, Blackburn	DATE OF SURVEY: 31/10/2017	SURVEYED BY: J. Robbie – A. Robbie
	CLIENT: Growth & Development Department, Blackburn with Darwen Borough Council	JOB NO: JPR/AR/2007	ANALYSIS COMPANY: North Star Environmental Ltd
Floor Level/Location:	Ground floor		
Area Description:	Area logged as G30 (Refer to diagram)

Sample Number	Sample FB/11	Material Risk Assessment (Refer to bottom of page for additional information)			
Product/Material Description:		*Internal/External	Internal/external	1	
Asbestos cement (A/C) roof sheets		Product/Material	A/C	0	
		*Asbestos Type	Chrysotile (white) asbestos	1	
		*Condition	Medium condition	2	
		*Access	Medium access	1	
		*Treatment	Composite material	0	
		Quantity	Approx 20 Sqm		
		Total Points:			05
Risk Assessment Category:			D

Recommendations/Comments:	Remove and dispose of as asbestos waste, prior to demolition. All works with asbestos must be undertaken in accordance with the current asbestos regulations (2012) and it's approved codes of practise.
Remediation/Management Comments:

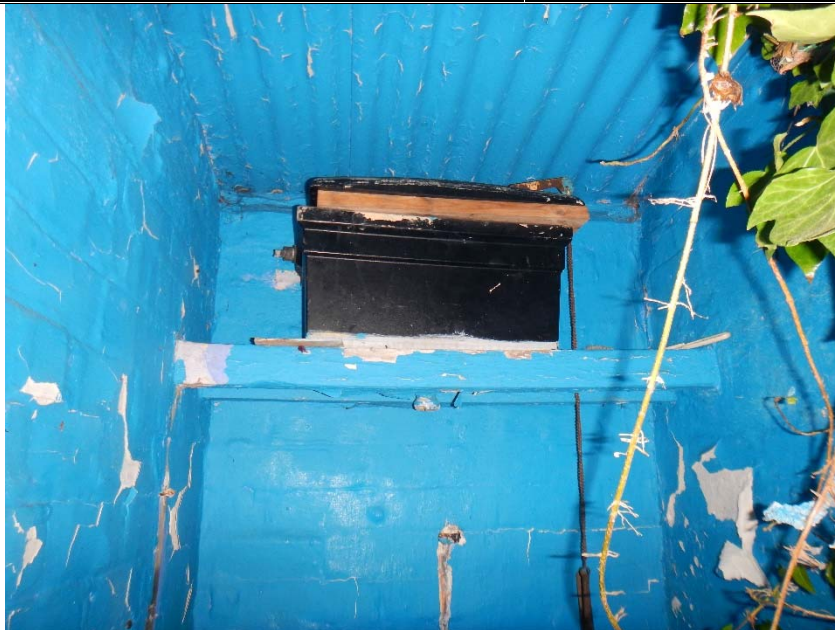
<p>4. Asbestos Survey Register (Survey Findings)</p>	BUILDING/ADDRESS: Higher House Farm Buildings, Blackamoor Road, Blackburn	DATE OF SURVEY: 31/10/2017	SURVEYED BY: J. Robbie – A. Robbie
	CLIENT: Growth & Development Department, Blackburn with Darwen Borough Council	JOB NO: JPR/AR/2007	ANALYSIS COMPANY: North Star Environmental Ltd
Floor Level/Location:	Ground floor		
Area Description:	Room logged as G31 (Refer to diagram)

Sample Number	Known Asbestos/5 (confirmed by the surveyor)	Material Risk Assessment (Refer to bottom of page for additional information)		
	Product/Material Description:	*Internal/External	Internal/external	1
	Asbestos containing W/C cistern	Product/Material	WC cistern	0
		*Asbestos Type	Amosite (brown) asbestos (Typically)	2
		*Condition	Good condition	0
		*Access	High access	2
		*Treatment	Composite material	0
		Quantity	X1	
			Total Points:	05
			Risk Assessment Category:	D

Recommendations/Comments:	Remove and dispose of as asbestos waste, prior to demolition. All works with asbestos must be undertaken in accordance with the current asbestos regulations (2012) and it's approved codes of practise.
Remediation/Management Comments:

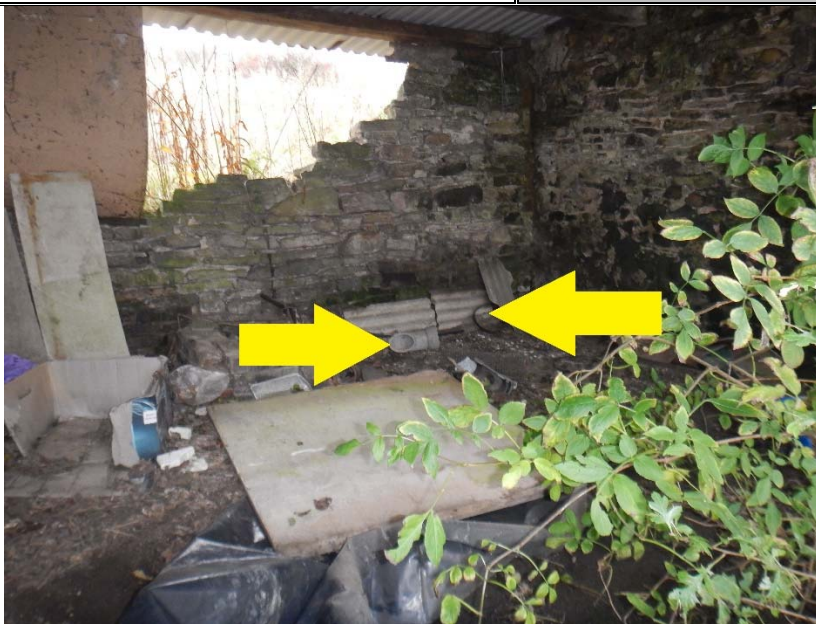
<p>4. Asbestos Survey Register (Survey Findings)</p>	BUILDING/ADDRESS: Higher House Farm Buildings, Blackmoor Road, Blackburn	DATE OF SURVEY: 31/10/2017	SURVEYED BY: J. Robbie – A. Robbie
	CLIENT: Growth & Development Department, Blackburn with Darwen Borough Council	JOB NO: JPR/AR/2007	ANALYSIS COMPANY: North Star Environmental Ltd
Floor Level/Location:	Ground floor		
Area Description:	Area logged as G35

Sample Number	As Sample FB/13(2)	Material Risk Assessment (Refer to bottom of page for additional information)	
Product/Material Description:		*Internal/External	Internal/external
Loose asbestos (A/C) cement sheets and an A/C tube to the ground (Approx 4 Sqm)		Product/Material	A/C
		*Asbestos Type	Chrysotile (white) asbestos
		*Condition	Poor condition
		*Access	High access
		*Treatment	Composite material
		Quantity	Approx 4 Sqm
		Risk Assessment Category:	C

As Sample FB/13(2) - Loose asbestos (A/C) cement sheets and an A/C tube to the floor (Approx 4 Sqm)

Recommendations/Comments:	Remove and dispose of as asbestos waste, prior to demolition. All works with asbestos must be undertaken in accordance with the current asbestos regulations (2012) and it's approved codes of practise.
Remediation/Management Comments:

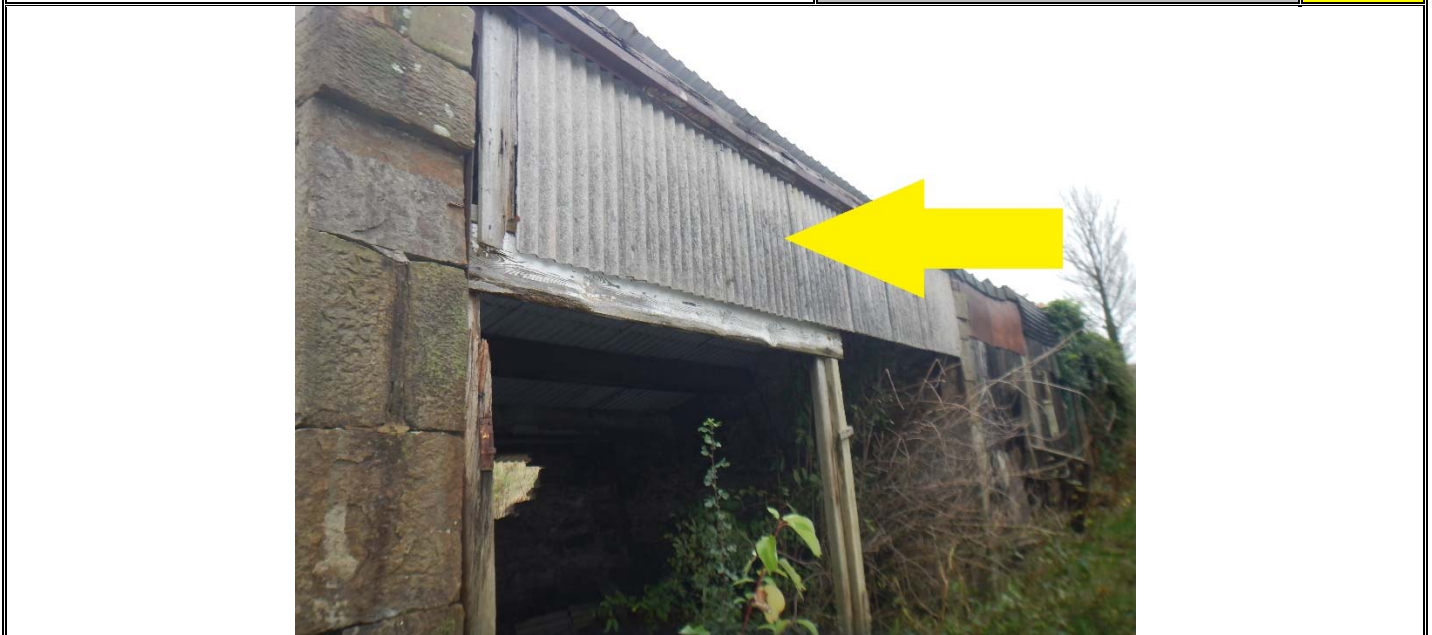
<p>4. Asbestos Survey Register (Survey Findings)</p>	BUILDING/ADDRESS: Higher House Farm Buildings, Blackamoor Road, Blackburn	DATE OF SURVEY: 31/10/2017	SURVEYED BY: J. Robbie – A. Robbie
	CLIENT: Growth & Development Department, Blackburn with Darwen Borough Council	JOB NO: JPR/AR/2007	ANALYSIS COMPANY: North Star Environmental Ltd
Floor Level/Location:	Ground floor		
Area Description:	Area logged as G35

Sample Number	As Sample FB/13(3)	Material Risk Assessment (Refer to bottom of page for additional information)	
Product/Material Description:		*Internal/External	Internal/external 1
Asbestos cement (A/C) fascia (Approx 6 Sqm)		Product/Material	A/C 0
		*Asbestos Type	Chrysotile (white) asbestos 1
		*Condition	Medium condition 2
		*Access	High access 2
		*Treatment	Composite material 0
		Quantity	Approx 6 Sqm
		Risk Assessment Category:	C

Recommendations/Comments:	Remove and dispose of as asbestos waste, prior to demolition. All works with asbestos must be undertaken in accordance with the current asbestos regulations (2012) and it's approved codes of practise.
Remediation/Management Comments:

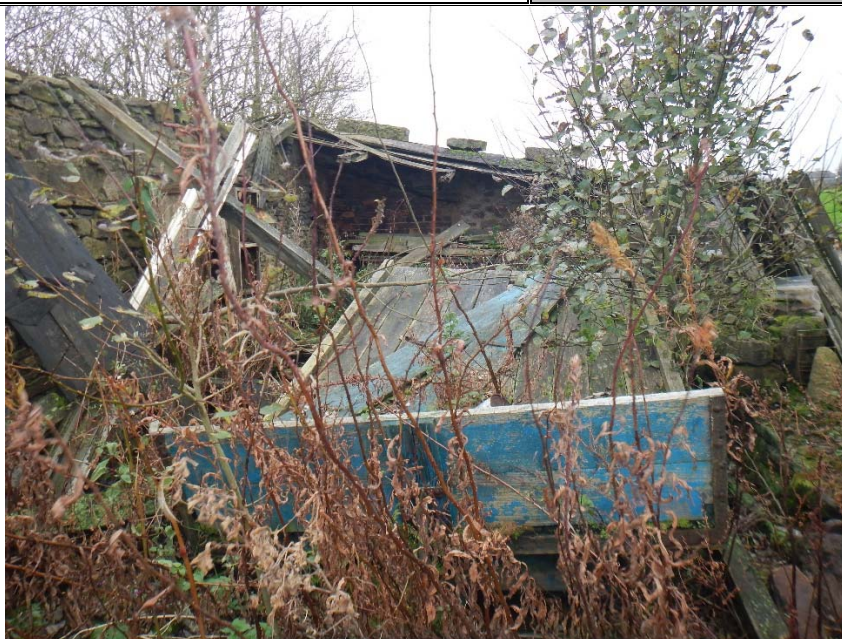
<p>4. Asbestos Survey Register (Survey Findings)</p>	BUILDING/ADDRESS: Higher House Farm Buildings, Blackmoor Road, Blackburn	DATE OF SURVEY: 31/10/2017	SURVEYED BY: J. Robbie – A. Robbie
	CLIENT: Growth & Development Department, Blackburn with Darwen Borough Council	JOB NO: JPR/AR/2007	ANALYSIS COMPANY: North Star Environmental Ltd
Floor Level/Location:	Ground floor		
Area Description:	Area logged as G36 / G37

Sample Number	As Sample FB/13(1)	Material Risk Assessment (Refer to bottom of page for additional information)			
Product/Material Description:		*Internal/External	External		
Asbestos cement (A/C) roof sheet debris, mixed in with general debris/overgrowth. The A/C debris is thought to have been the roof of the structure (Approx 20 Sqm)		Product/Material	A/C		
		*Asbestos Type	Chrysotile (white) asbestos		
		*Condition	Poor condition		
		*Access	High access		
		*Treatment	Composite material		
		Quantity	Approx 20 Sqm (Guessed)		
		Total Points:		07	
		Risk Assessment Category:		C

Recommendations/Comments:	Remove and dispose of as asbestos waste, prior to demolition. All works with asbestos must be undertaken in accordance with the current asbestos regulations (2012) and it's approved codes of practise.
Remediation/Management Comments:

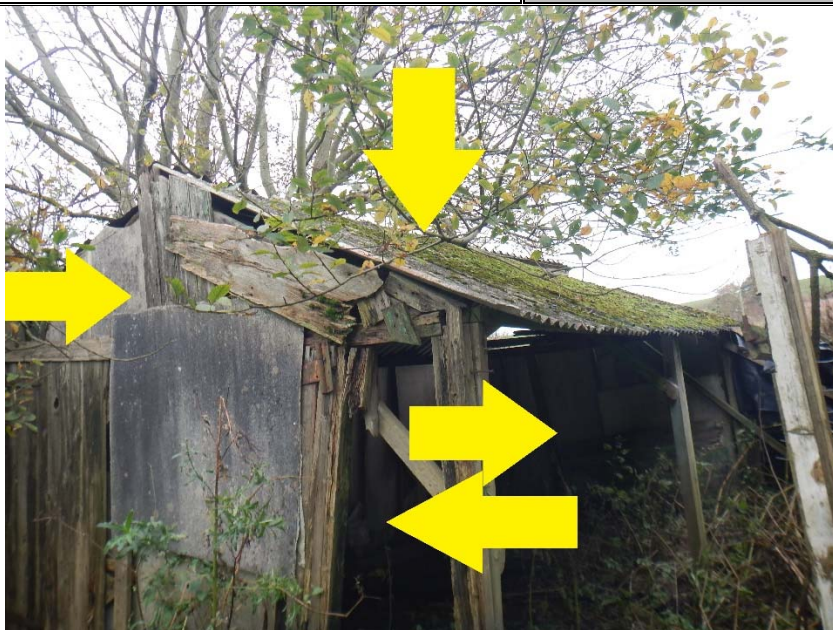
Sample FB/13	External	Structure logged as G41	Asbestos cement (A/C) roof and wall sheets, the ACM is in poor condition with loose associated debris present	C	Remove/dispose of as asbestos waste

<p>4. Asbestos Survey Register (Survey Findings)</p>	BUILDING/ADDRESS: Higher House Farm Buildings, Blackmoor Road, Blackburn	DATE OF SURVEY: 31/10/2017	SURVEYED BY: J. Robbie – A. Robbie
	CLIENT: Growth & Development Department, Blackburn with Darwen Borough Council	JOB NO: JPR/AR/2007	ANALYSIS COMPANY: North Star Environmental Ltd
Floor Level/Location:	Ground floor		
Area Description:	Structure logged as G41

Sample Number	Sample FB/13	Material Risk Assessment (Refer to bottom of page for additional information)	
Product/Material Description:		*Internal/External	External 0
Asbestos cement (A/C) roof and wall sheets, the ACM is in poor condition with loose associated debris present		Product/Material	A/C 0
		*Asbestos Type	Chrysotile (white) asbestos 1
		*Condition	Poor condition 4
		*Access	High access 2
		*Treatment	Composite material 0
		Quantity	Approx 40 Sqm
		Total Points:	
Risk Assessment Category:		C

Recommendations/Comments:	Remove and dispose of as asbestos waste, prior to demolition. All works with asbestos must be undertaken in accordance with the current asbestos regulations (2012) and it's approved codes of practise.
Remediation/Management Comments:
