DARWEN MARKETS, DARWEN,
BB3 1BG

CCTV Inspection Report

**DARWEN 3 DAY MARKET
SCHOOL STREET
CROFT STREET
DARWEN
BB3 1BH**

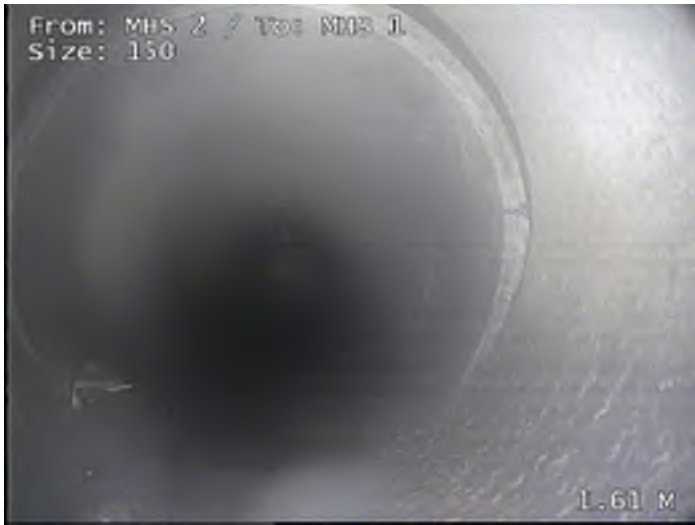
Open joint medium

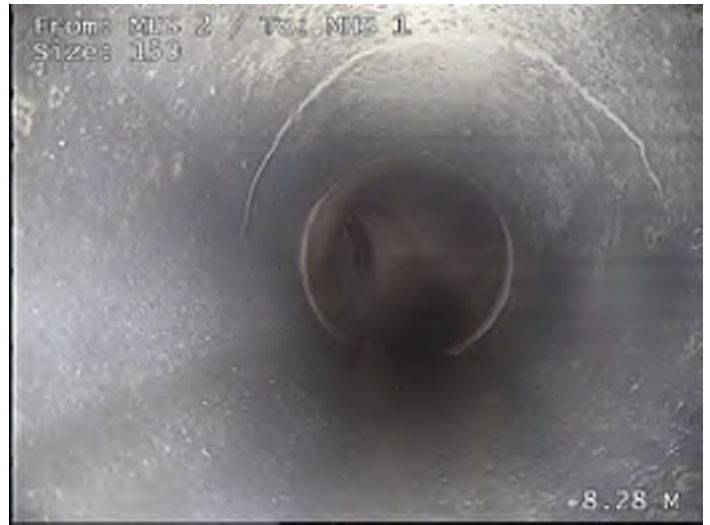
Fracture circumferential from 9 to 3 o'clock

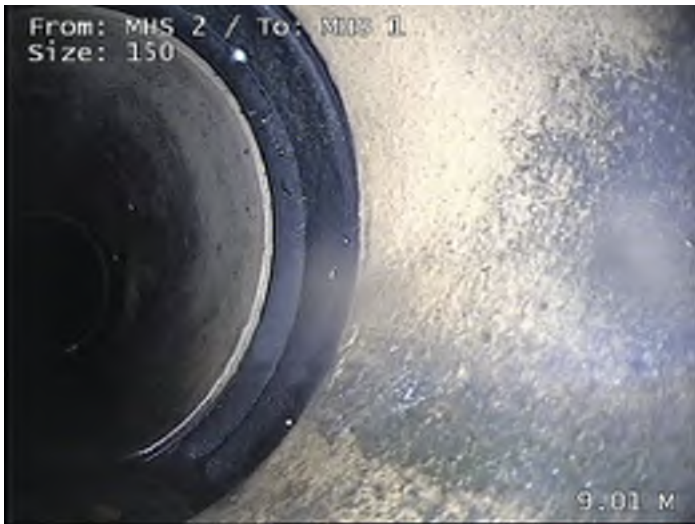
Open joint medium

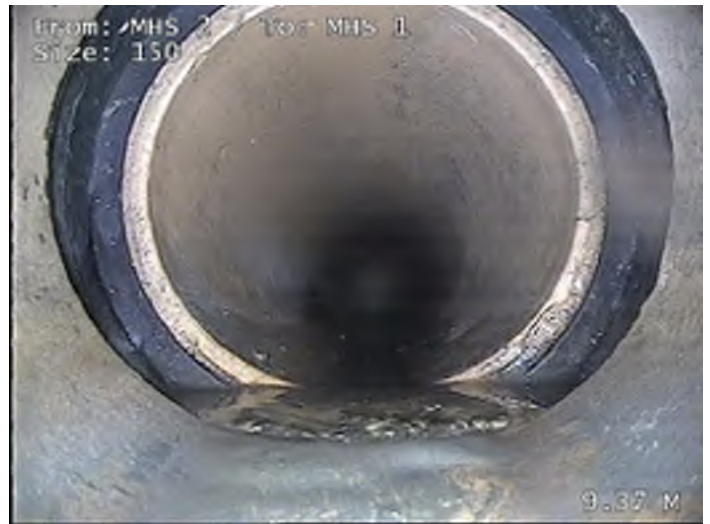
Open joint medium

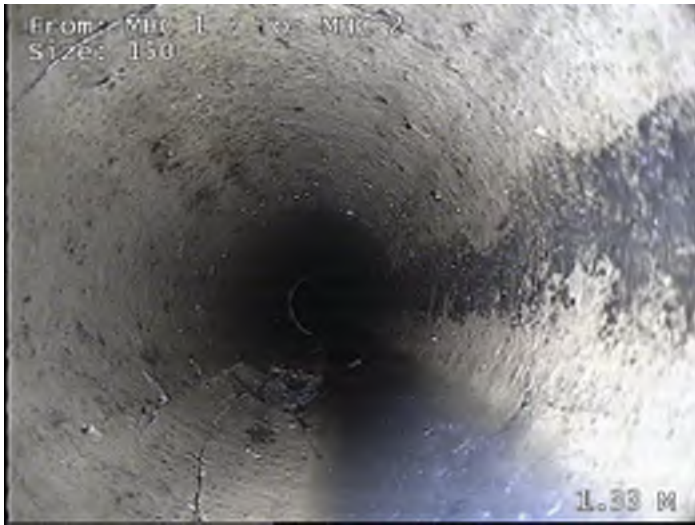
Fracture circumferential from 12 to 12 o'clock

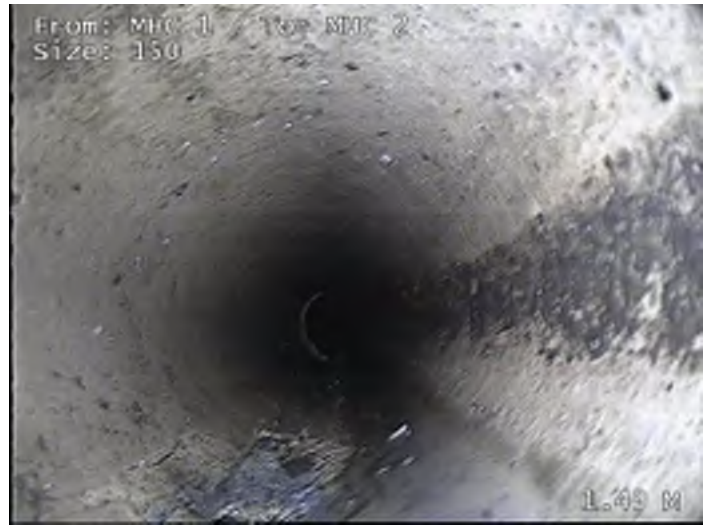
Broken pipe at 7 o'clock

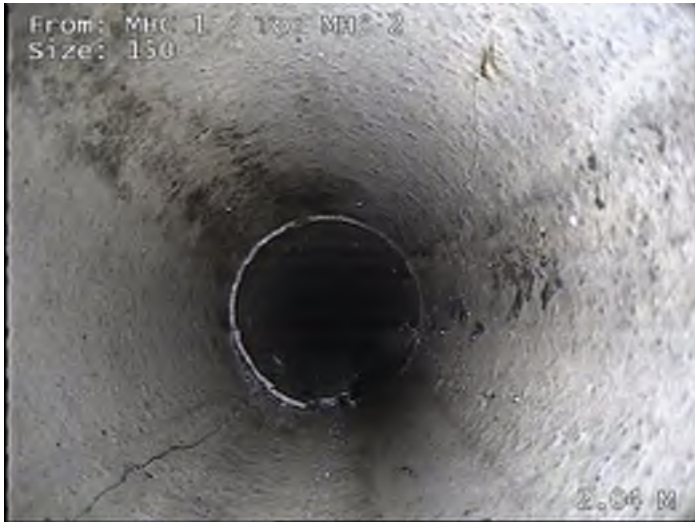
Fracture longitudinal at 7 o'clock

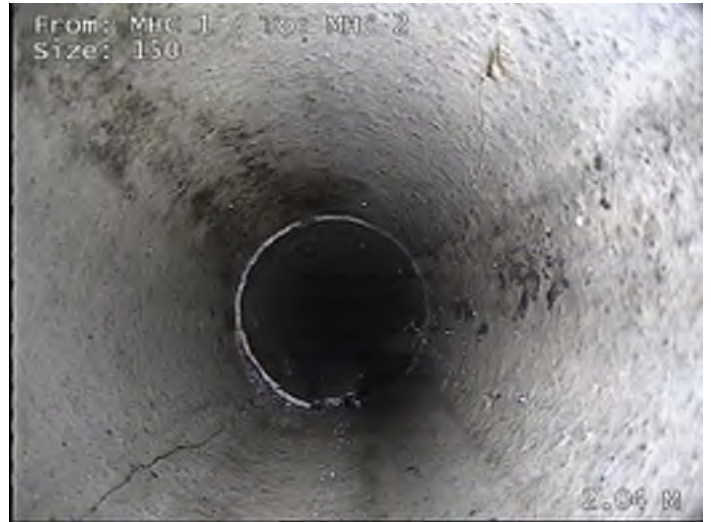
Fracture longitudinal at 1 o'clock

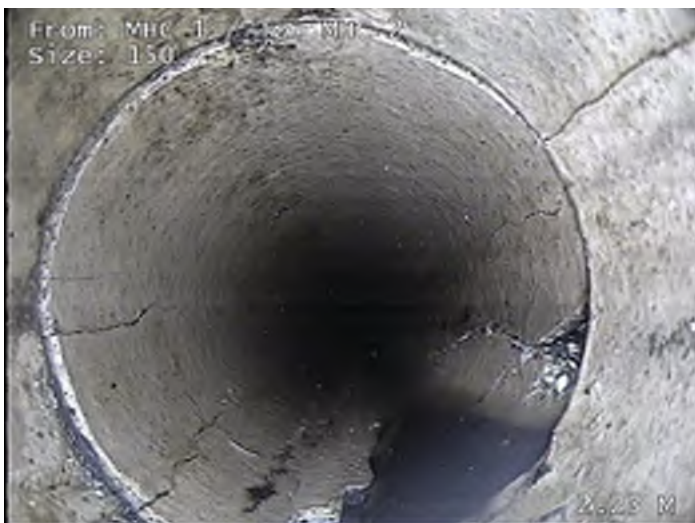
Broken pipe from 2 to 9 o'clock

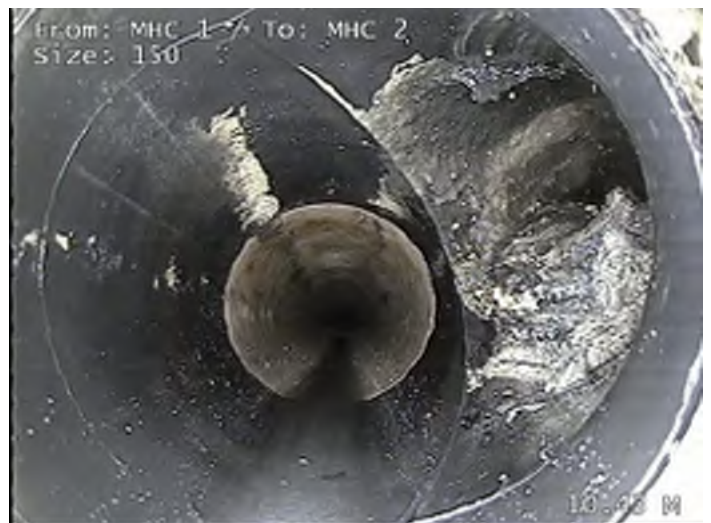
FAT AND GREASE IN JUNCTION.

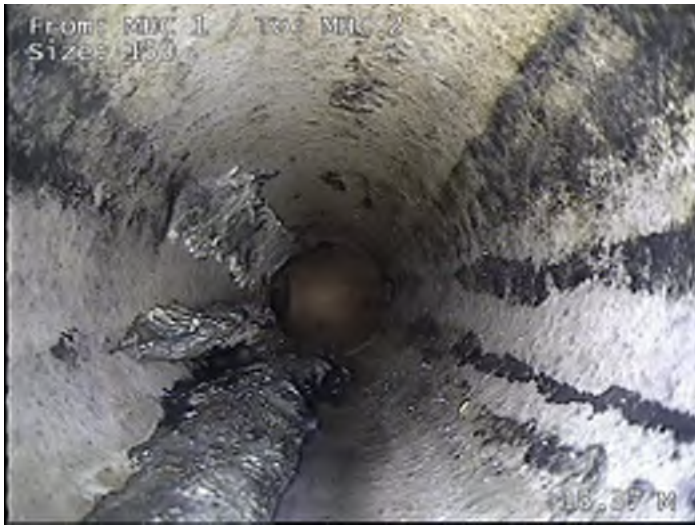
Attached deposits, encrustation from 11 to 6 o'clock 10% cross sectional area loss

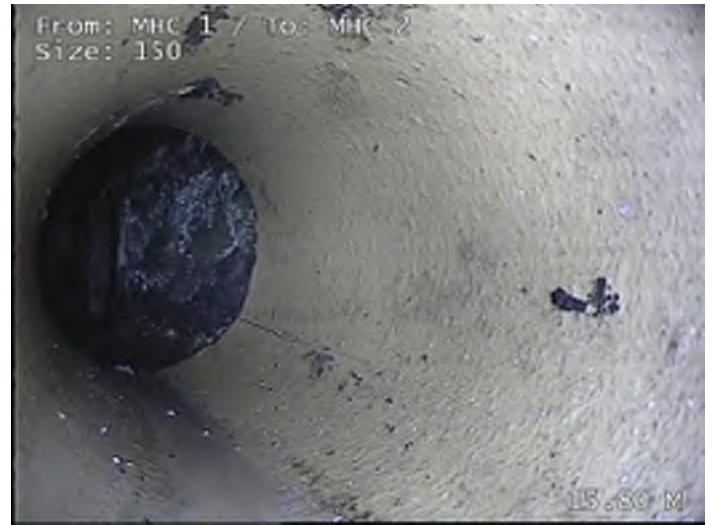
Fracture longitudinal at 5 o'clock

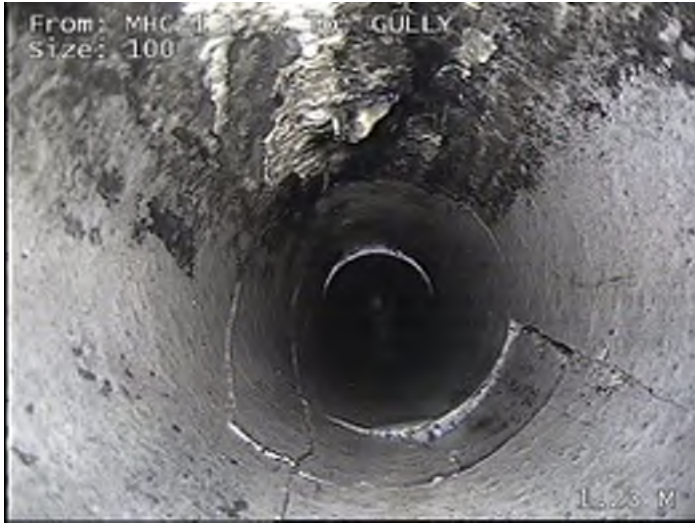
Broken pipe from 2 to 10 o'clock

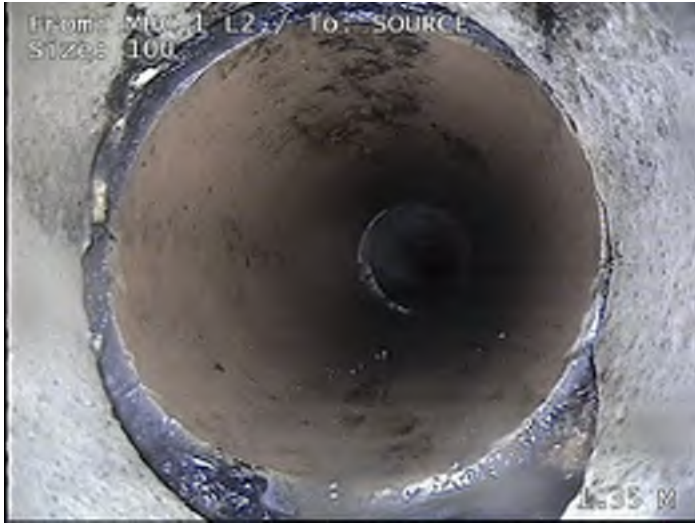
Hole in drain/sewer at 6 o'clock

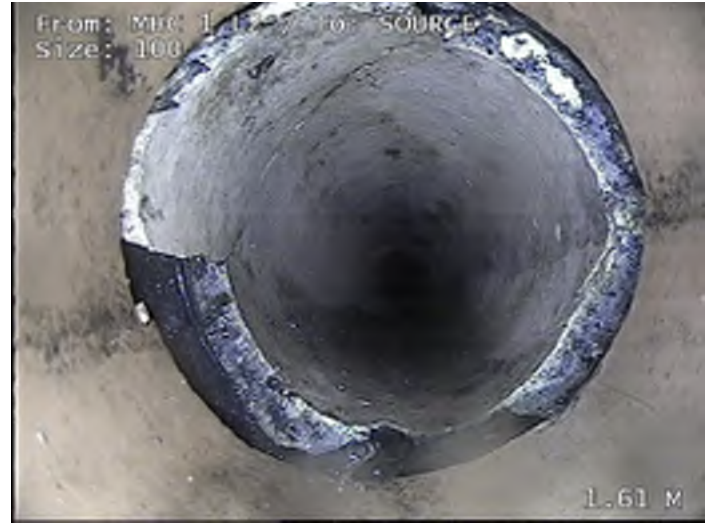
Broken pipe from 12 to 12 o'clock

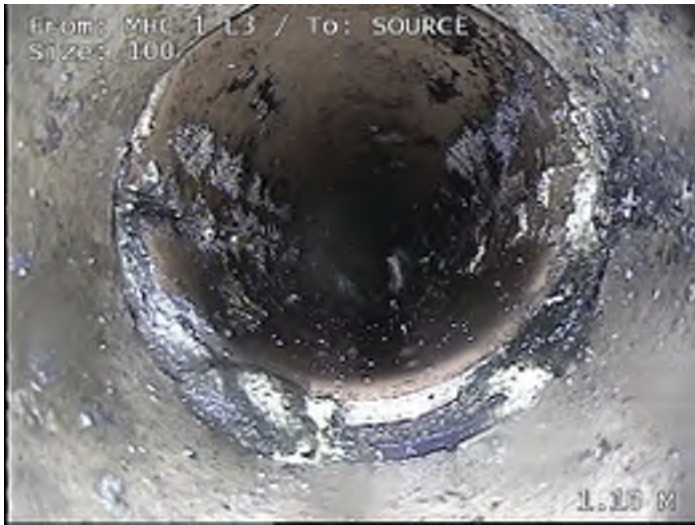
Joint displaced medium

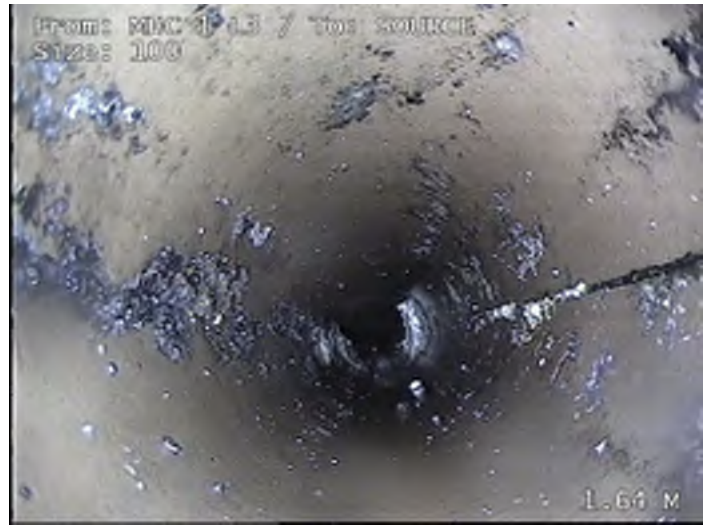
Fracture longitudinal at 3 o'clock

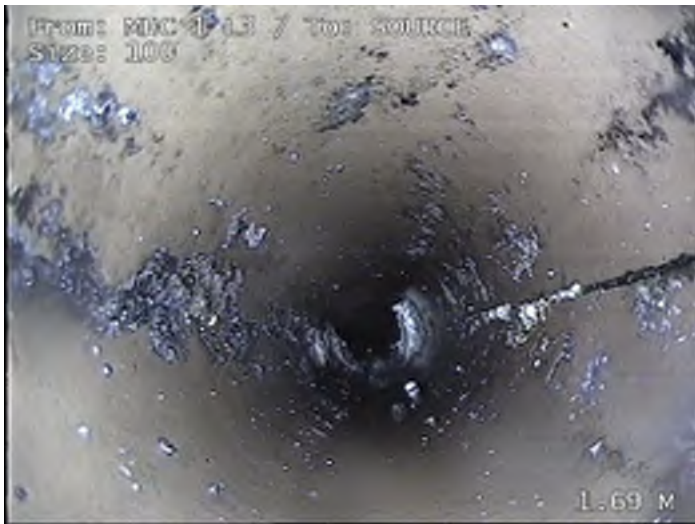
Fracture longitudinal at 9 o'clock

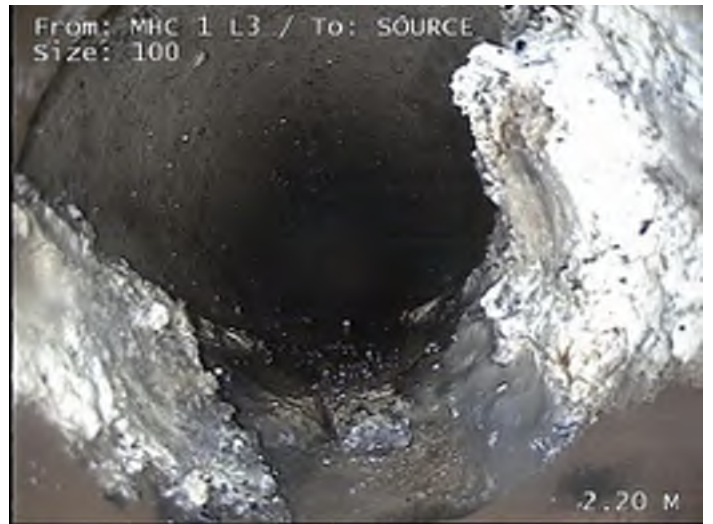
Attached deposits, grease from 1 to 10 o'clock 15% cross sectional area loss

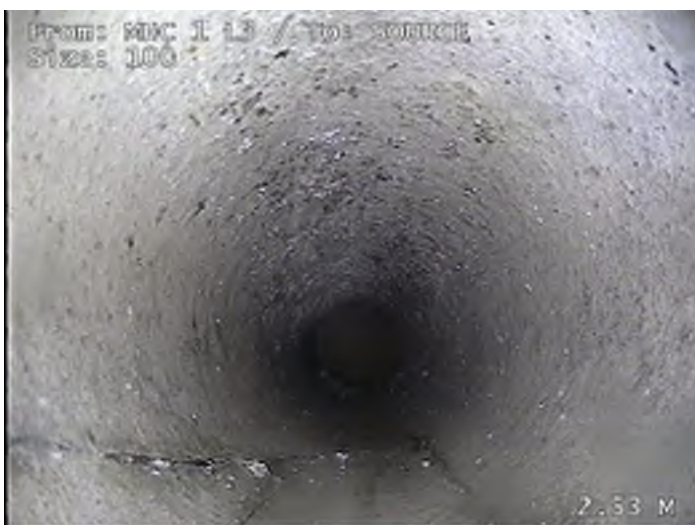
Broken pipe from 8 to 4 o'clock

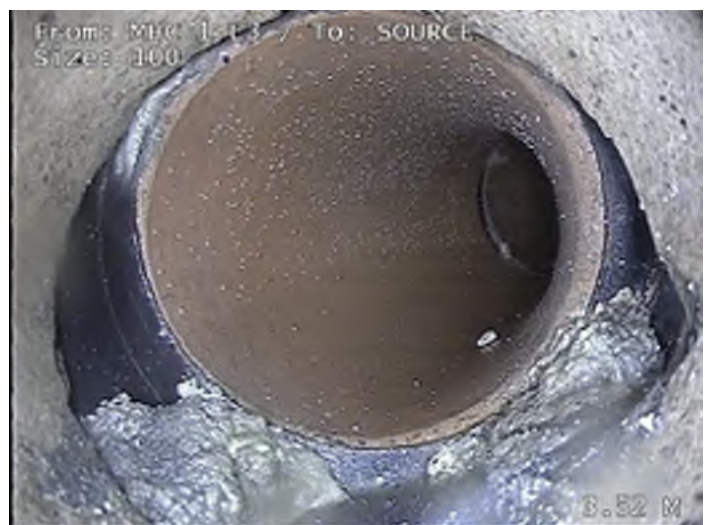
Open joint large

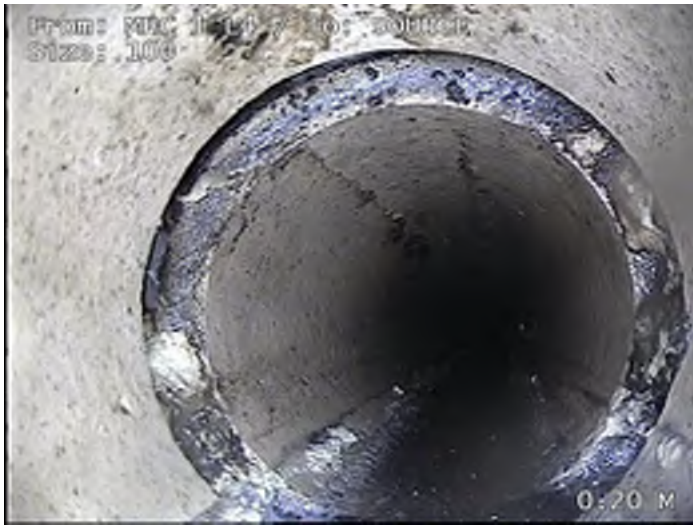
Open joint medium

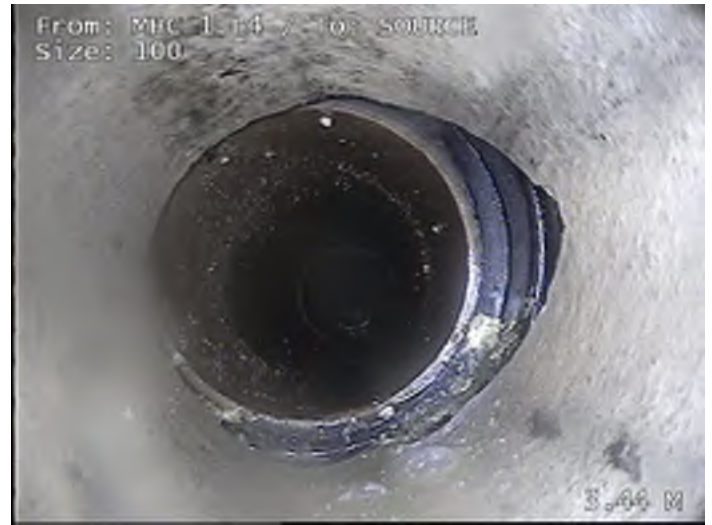
Broken pipe from 12 to 12 o'clock

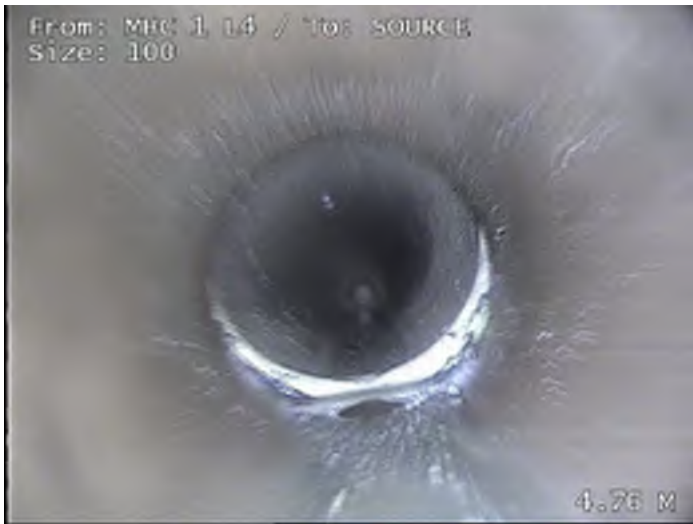
Joint displaced medium

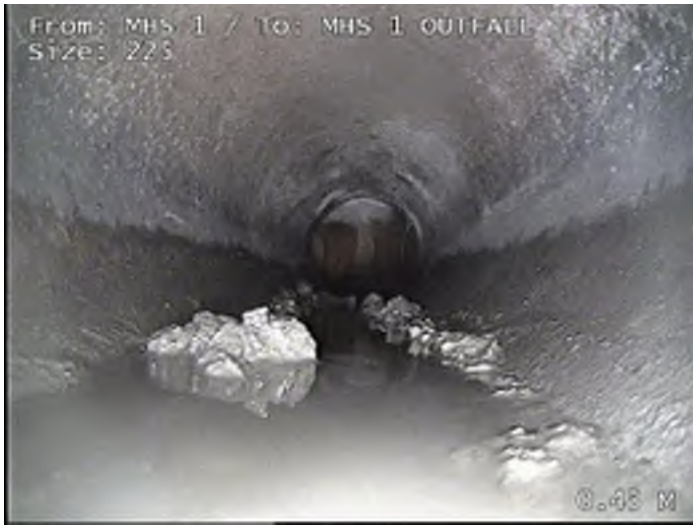
Settled deposits fine 10% cross-sectional area loss

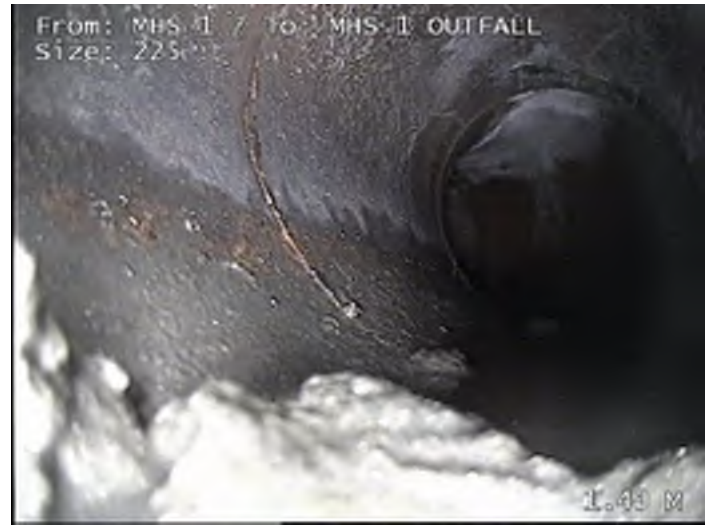
Fracture circumferential from 7 to 11 o'clock

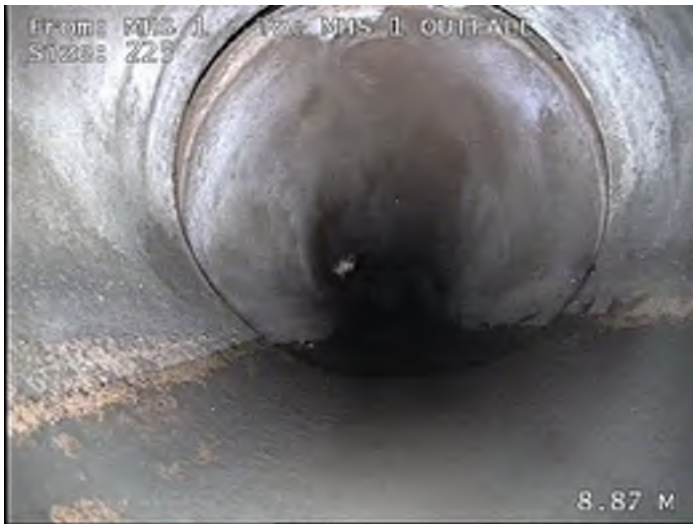
Joint displaced medium
