TECHNICAL REPORT ON A SUBSIDENCE CLAIM

Crawford Reference: SU1704316

**Mr David & Mrs Janet Hartley
215 Revidge Road
Blackburn
BB2 6DT**

SUBSIDENCE CLAIM

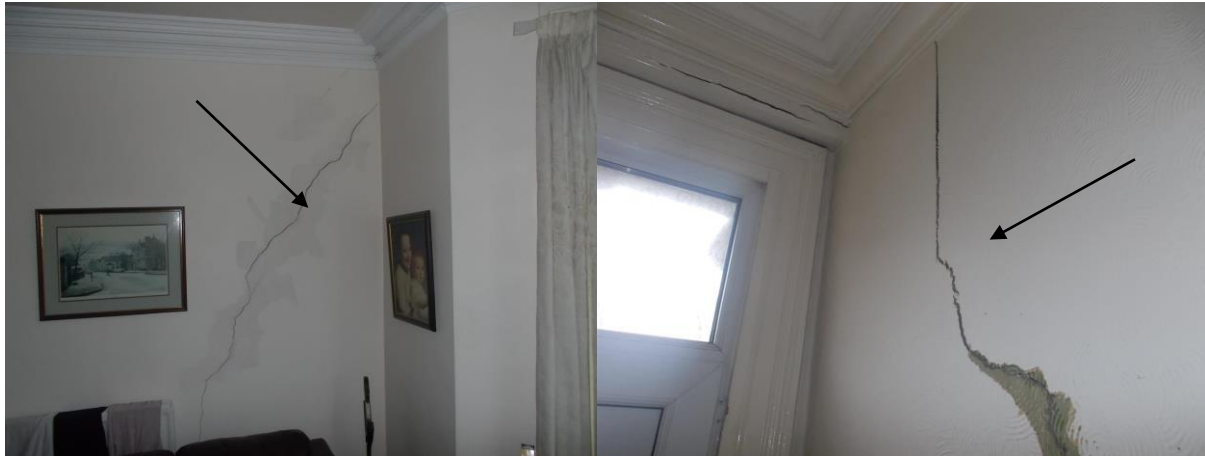
Cracking to the right-hand wall in the front lounge

Cracking to the left-hand wall in the front lobby

Diagonal cracking up to 5mm wide is noted to the right-hand wall. The cracking extends into the coving in the front right-hand corner.

Diagonal and vertical cracking up to 5mm wide is noted to the left-hand wall (this mirrors the cracking in the lounge). The cracking extends into the coving and across the head of the front door.

Cracking 2mm wide is noted to the front right-hand junction between the wall and front door.

In structural terms the damage falls into Category 3 of Table 1, Building Research Establishment¹ Digest 251, which describes it as “moderate”.

The pattern and nature of the cracks is indicative of an episode of subsidence. The most probable cause of the movement appears to be clay shrinkage, however there is underground drainage at the front of the property and therefore leaking drains also remain a possible cause.

The timing of the event and the proximity of vegetation where there is damage indicates the damage may be due to root induced clay shrinkage. This is a commonly encountered problem and probably accounts for around 70% of subsidence claims notified to insurers.

A site and drainage investigation is to be carried out to assist in determining the cause of the damage to the front part of the property. An update will be provided following receipt of the investigation report.

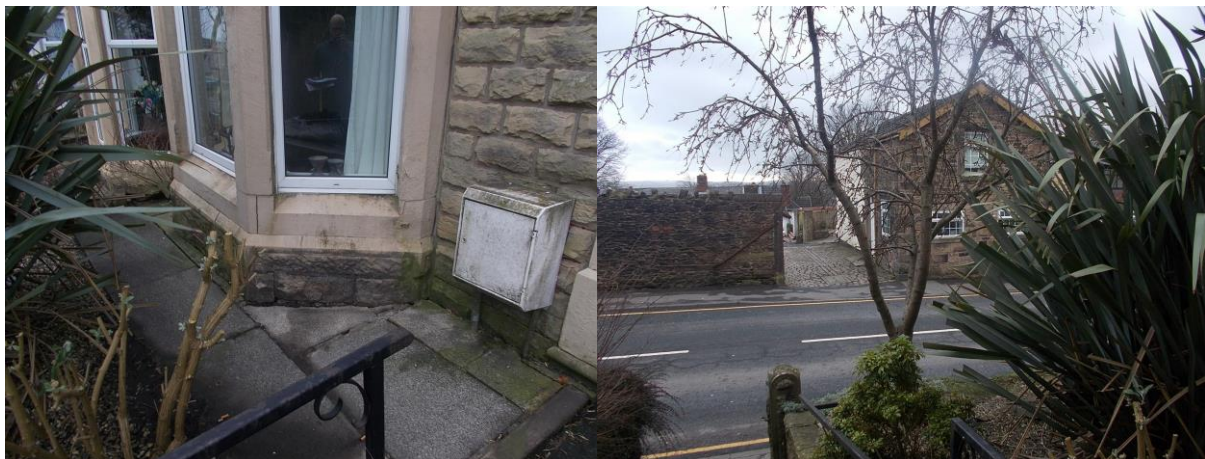
Front elevation and bay window. NB. The gas meter box is approximately in line with where the cracking is internally

Laburnum in front garden

No damage is noted externally.

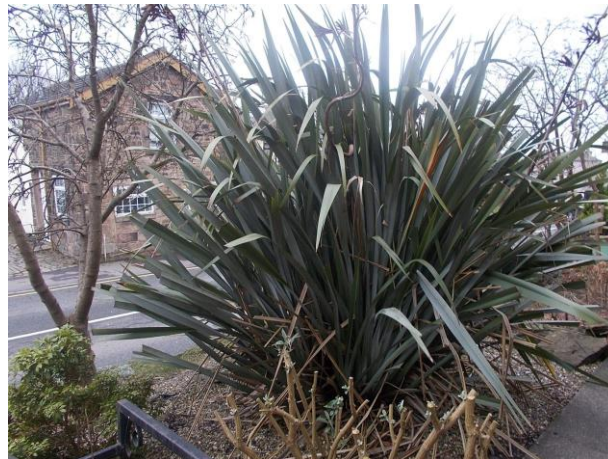
Large shrub in insured front garden
