# *Martin Prescott Environmental Services*

*Woodland Management, Ecological  
Surveying, Wildlife Events...*

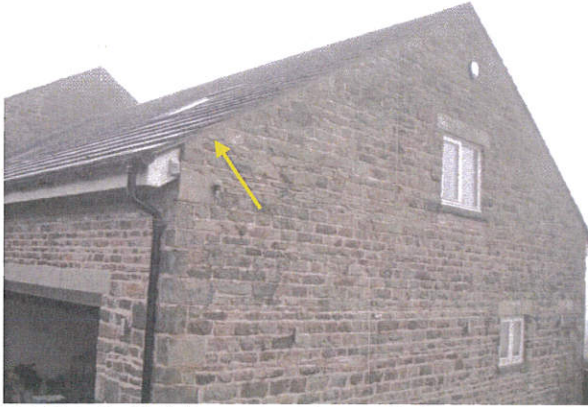
P1 South Gable, gap under end tile
