**Daytime Building Inspection and Site Walkover
Outbuildings off Blackamoor Road, Blackburn**

November 2017

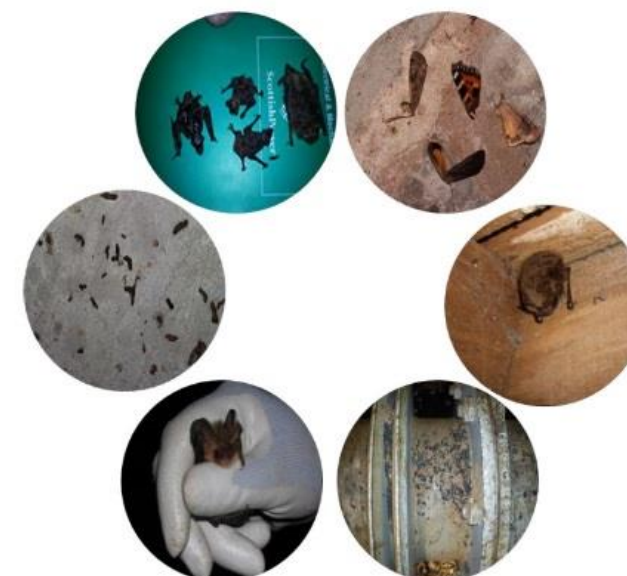
Field signs of bat presence:

- Live or dead bats: the smallest UK bat species, the pipistrelle is only 3.5-4.5cm long.
- Droppings: bat droppings look like mouse droppings but will crumble between your fingers (they are dry and made entirely of insects).
- Feeding remains: piles of butterfly/moth wings are often left below bat feeding perches.

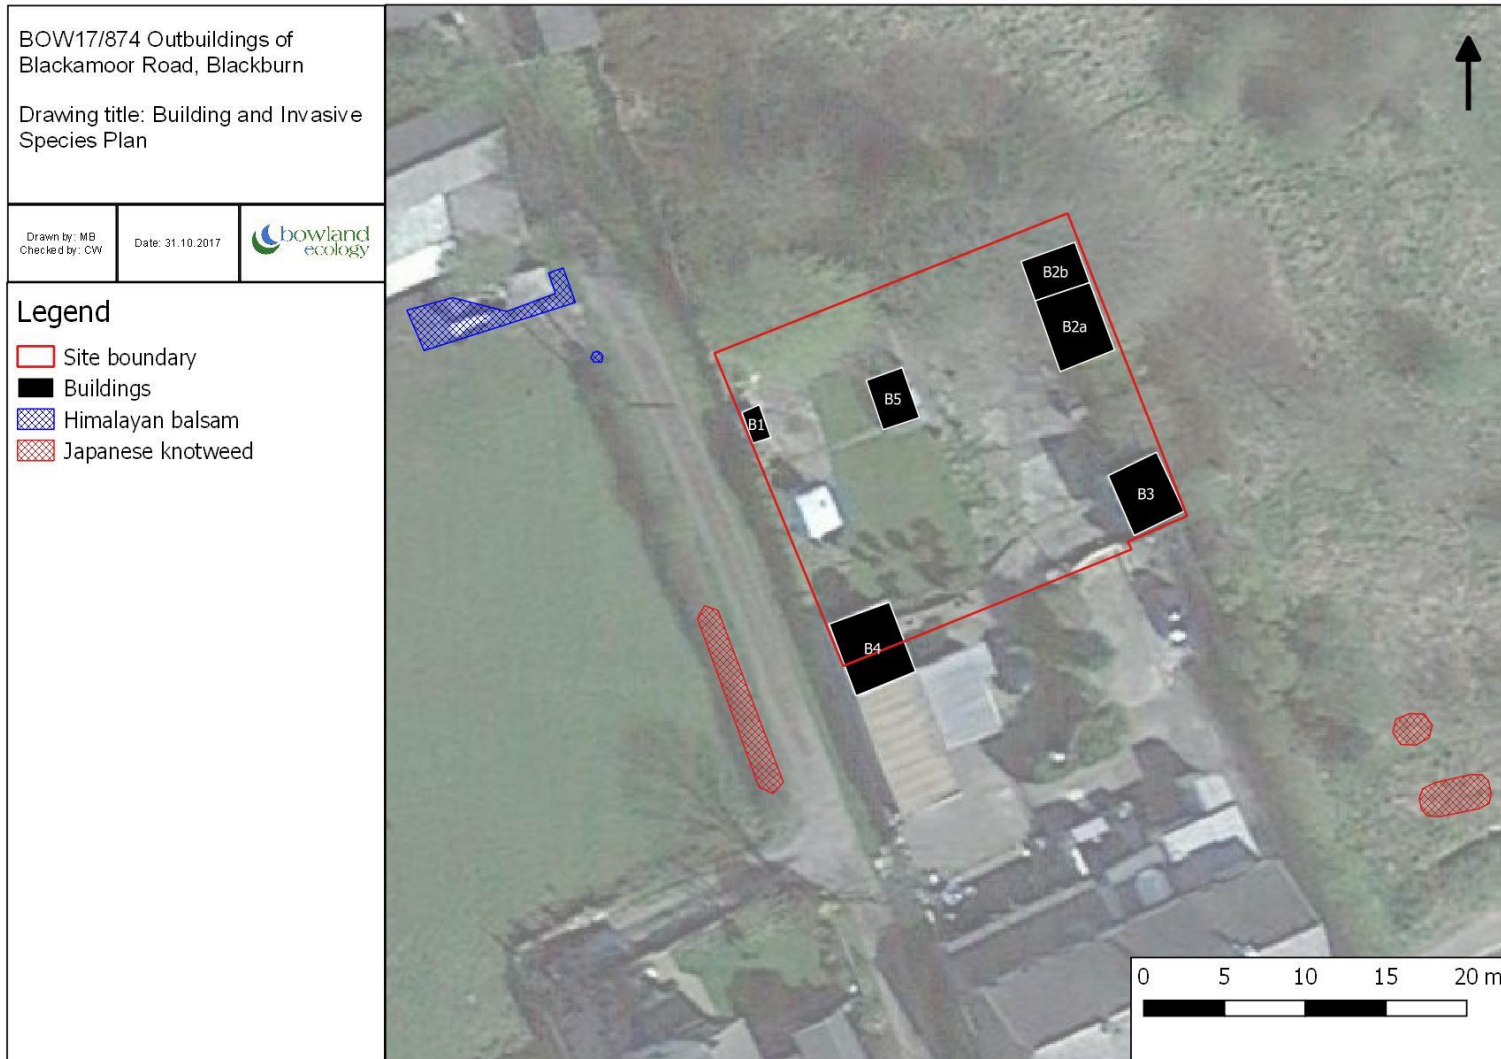
Appendix D – Building and Invasive Species Plan

- 3.20 Japanese knotweed is located along the western side of the access track leading down to the Site. The plant is located within 5 m of Building 4. There are also several stands of the plant located in rank grassland to the east of the Site, outside of the Site boundary.
- 3.21 Himalayan balsam is present at the bottom of the access track leading to the Site. The closest stand is located approximately 9 m north west of Building 1. The locations of the aforementioned plants are detailed on the Building and Invasive Species Survey Plan in Appendix D.

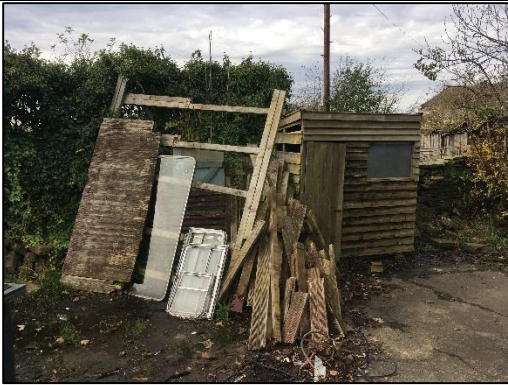
Building 1 – Externally

- 3.10 **Building 1** is a very small, single storey, timber shed, measuring 2 m x 1 m x 2 m. The building has a sloping, metal corrugated roof which was found to be in good condition. Gaps of approximately 3 cm x 15 cm are present beneath the corrugated roofing material. These gaps are considered too large and exposed to provide suitable bat roosting habitat. Many of the timber wall panels were found to be in relatively poor condition, showing signs of damp and rot. On the western elevation of the building, dense ivy (*Hedera helix*) cladding is present which has the potential to provide habitat for small numbers of roosting bats.

- Before any works proceed all contractors should be made aware of the possible presence of bats, bat field signs to look for and procedure if bats are found or discovered (see Appendix C);
- Hand removal of corrugated roofing material, timber fascias and ivy cladding;
- A suitably qualified ecologist should be on call during the works and if a bat is found, the ecologist will attend Site, remove the bat, check the health of the bat and then place it in a suitable bat box;
- Work to cease immediately if bats are encountered at any stage, works can only resume once advice from a suitably qualified ecologist has been sought; and
- If a bat is in immediate danger it should only be picked up with **gloved hands** and placed in a secure container with air holes and placed in a dark, quiet place until the ecologist arrives at Site.

5.3 Works to remove the ivy cladding and timber fascias will take place outside the breeding bird season which runs from March until August inclusive, in order to prevent any impacts upon breeding birds.

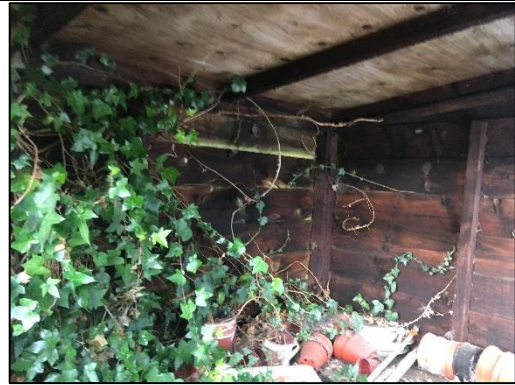
Building 1 – Internally

- 3.11 Internally, the roof of the building is lined with timber panels, potentially creating a very small cavity that could be used by individual crevice dwelling bats. Some of the ivy cladding has also grown through the timbers, and may provide bat roosting habitat. The door to the shed is slightly ajar and there are missing timber panels on the southern elevation which would make the internal space cold and draughty, thus unsuitable for roosting bats. No evidence of roosting bats was noted during the survey. The building is considered to provide **low** potential to support roosting bats.

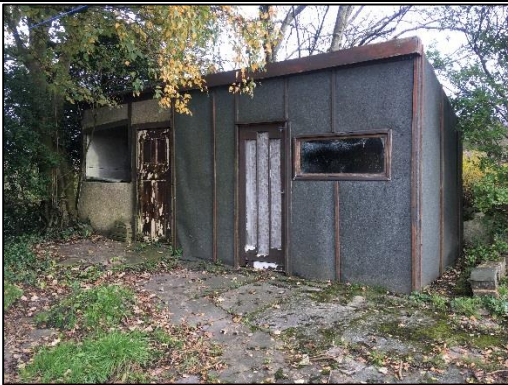
Building 2 - Externally

- 3.12 **Building 2** is a small, single storey outbuilding, with two separate sections (2a & 2b) both of which were found to be in a poor state of repair with rotting timbers. The roof is gently sloping and is covered with roofing felt which was found to be intact to the south but rotten at the northern section of the building (2b), with large gaps allowing access into the internal space. The external sides of the building are covered with felt, beneath which is a timber frame. The room to the north is in poor condition, the window is missing and there are gaps in the roof. Timber fascias are present along the western elevation. These are showing signs of water damage with several gaps along the elevation. The gaps potentially provide internal access for bats to the space between the felt roofing material and timber lining.

- 3.19 The dense ivy cladding on the western elevation of Building 1 provides suitable nesting habitat for small birds. Furthermore, an entrance to a birds nest was noted where there are gaps in the fascia on Building 2. Numerous bird droppings were located at the gap in the fascia.

5.4 Any clearance works, including removal of ivy cladding and timber fascias that must be carried out within the bird breeding season will be subject to a pre-clearance bird survey carried out by a suitably experienced ecologist. No clearance will be carried out within 5 m of an identified nest until the young have fledged and are no longer returning to the nest site. The area will only be cleared once a scheme ecologist has declared the nest to be no longer in use.

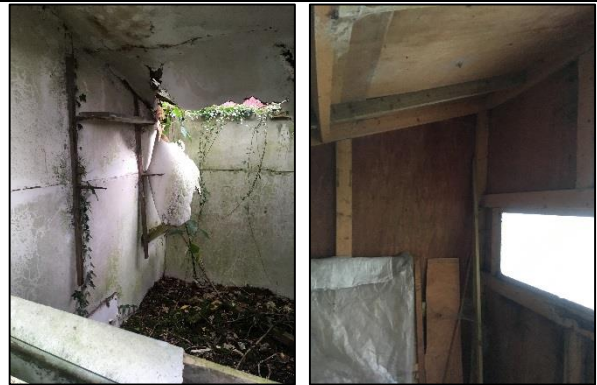
Building 2 - Internally

- 3.13 Internally, the building to the south (2a) is clad with timber, providing potential bat roosting habitat between the timber lining and felt outer covering. The building is used for storage, as such, it is relatively cluttered and was found to be heavily cobwebbed. The absence of the window and missing roof on the northern section renders the internal space unsuitable for roosting bats as it is cold, wet and draughty. No evidence of roosting bats was noted during the survey. As such, the building is considered to provide **low** potential to support roosting bats.

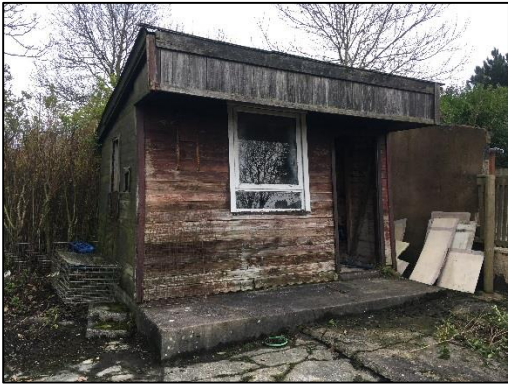
Building 3 - Externally

- 3.14 **Building 3** is a small, timber shed, approximately 3 m x 5 m x 3 m with a sloping, corrugated metal roof. The timbers are in poor condition showing signs of damp, and the window on the northern elevation is broken. Timber fascia boards are present on the north, south and western elevations. A section of the fascia is missing on the northern elevation leaving a 5 cm gap between the corrugated roofing material and the timber roof lining. This gap potentially provides roosting habitat for very small number of crevice dwelling bats. The section of roof on the western elevation overhangs the walls, with small gaps suitable for individual crevice dwelling bats present beneath the corrugated roofing material and the timber lining, also present along this section.

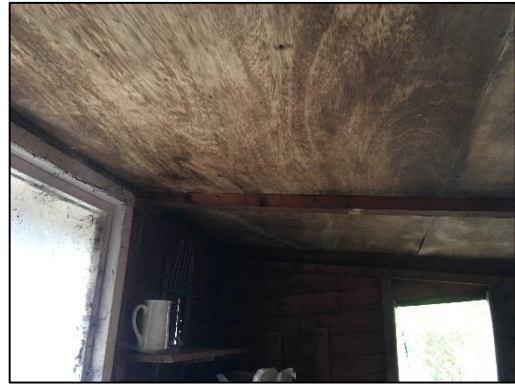
Building 3 - Internally

- 3.15 Internally, the building is used for storage and was found to be cluttered and the roof densely covered with cobwebs. Timber plywood lining is present on the walls and the roof. No evidence of roosting bats was noted during the survey. The building is considered to have **low** potential to support roosting bats.

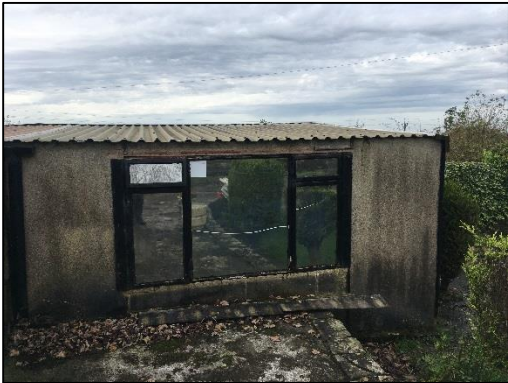
Building 4 - Externally

- 3.16 **Building 4** is a single storey garage with a flat, corrugated metal roof and chip board type material covering the walls. Small gaps (approximately 3 cm x 5 cm) are present beneath the corrugated roofing material that may potentially provide habitat for small numbers of crevice dwelling bats. The building is connected to garage buildings to the south, on the adjoining land.

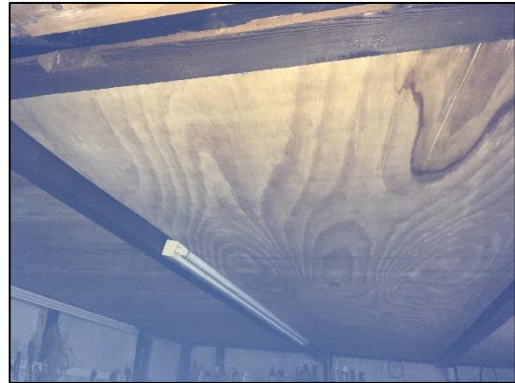
Building 4 - Internally

- 3.17 Internally, the building is used for storage and is cluttered. The walls and ceiling are clad with timber. No features suitable for roosting bats were noted during the internal inspection and evidence of water ingress was noted on the timber roof lining. No evidence of roosting bats was noted during the survey. The building is considered to have **low** potential to support roosting bats.

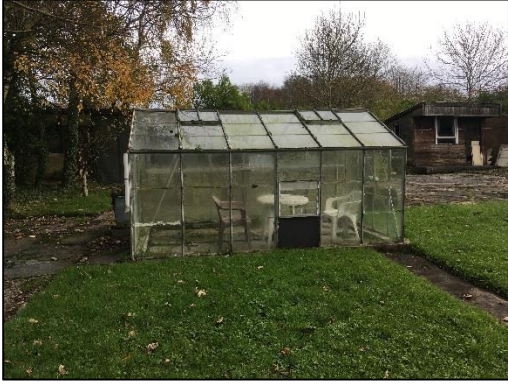
Building 5

- 3.18 **Building 5** is a small glasshouse with a metal frame. Two of the glass panes on the eastern side are broken. No habitat suitable for roosting bats was noted during the survey. The building is considered to have **negligible** potential to support roosting bats.

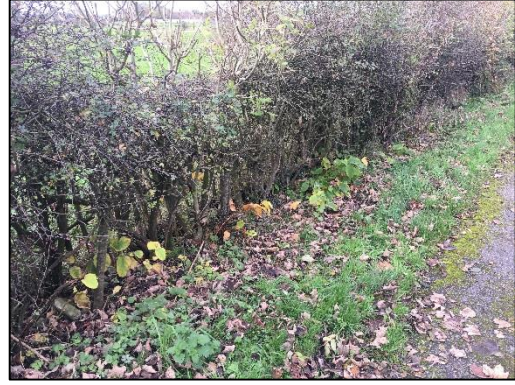
Stand of Japanese knotweed along access track

- Contractors to be aware of the location of Himalayan balsam and Japanese knotweed;
- Marking off all stands of Himalayan balsam/Japanese knotweed with hi-visibility netlon fencing; and
- Biosecurity measures to be implemented whilst on site to prevent cross contamination. This involves the cleaning of footwear and machinery, prior to, and on completion of each working window to ensure that invasive species are not taken off site.

5.6 Under the Environmental Protection Act 1990 Sections 33 and 34, Japanese knotweed must be treated as controlled waste, as such all arisings and potentially contaminated soil from the plant must be disposed of in an appropriate manner to ensure that the waste does not cause pollution of the environment.

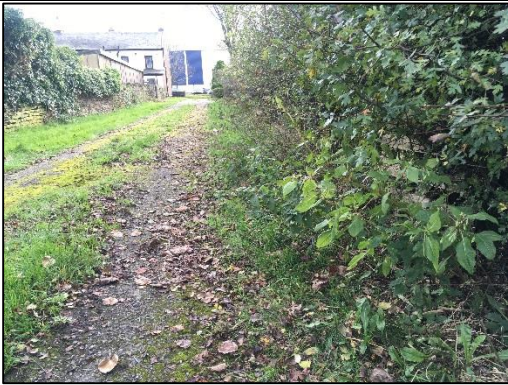
Stand of Himalayan balsam along access track
