**Barcroft, Carr Lane, Blackburn,
Lancashire
BB2 6QS**

**Survey & Assessment in Respect of
Bat Species and Nesting Birds.**

Echo Calls Bat Surveys

2nd October 2017

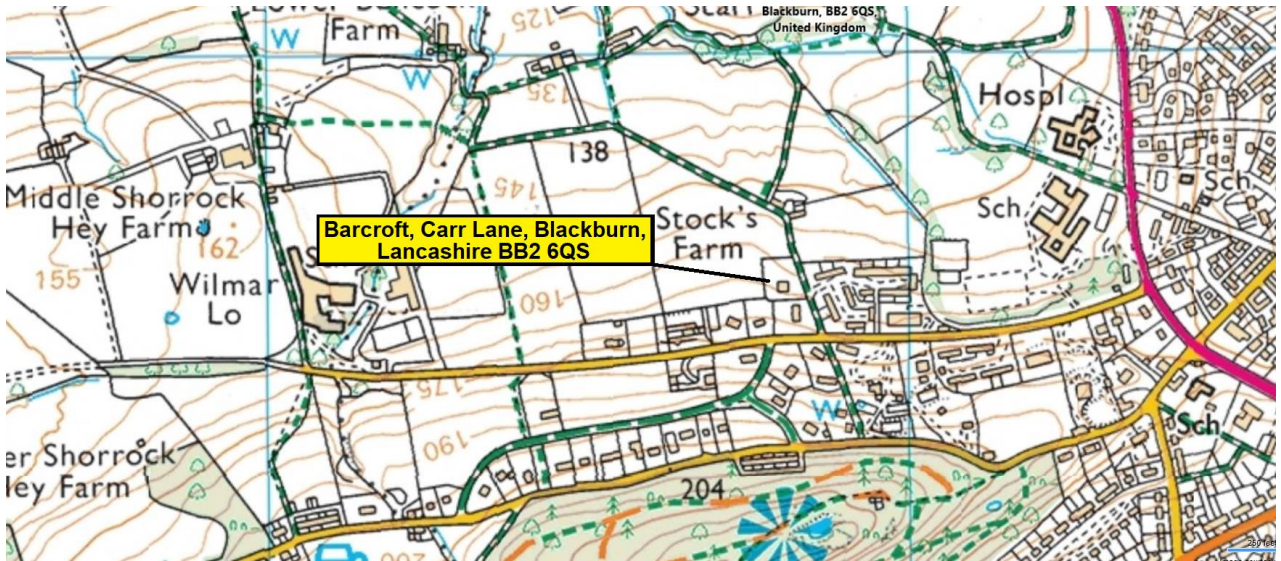
Fig 1 - The Site Location

The site was located along the western edge of Carr Lane, in the Blackburn area of Lancashire, and consisted of a single detached dwelling positioned close to the southern boundary of the site. The land and buildings from now on, are referred to as the "site", at OS grid reference: SD 65811 28647, (refer to **Fig 1 - The Site Location**).

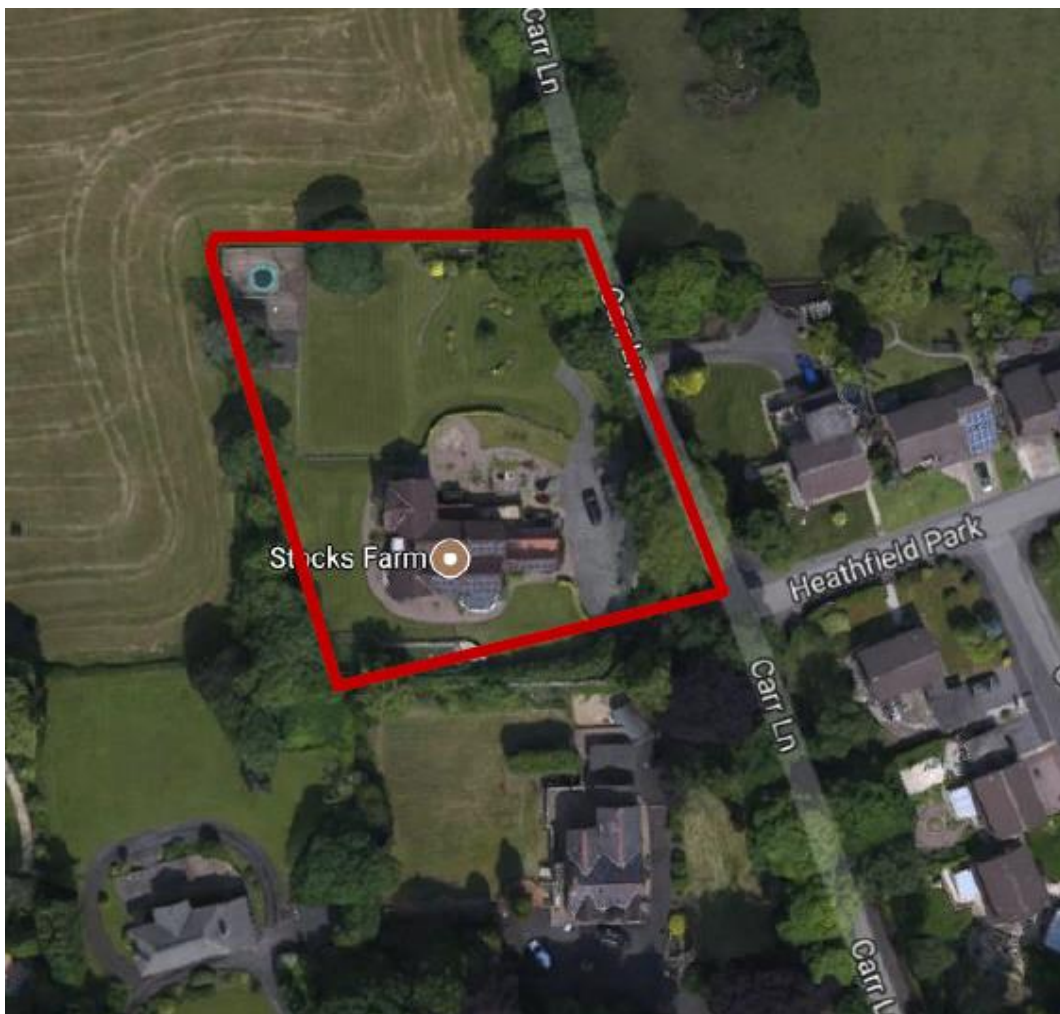
Fig 2 – Google Plan

There were no areas of woodland or waterways close to the site, however, Woodfield Park some distance away to the west contained woodland and several large ponds, whilst a half kilometer away to the south, was Bilinge Hill which was covered in trees, (refer to **Fig 2 – Google Plan**).

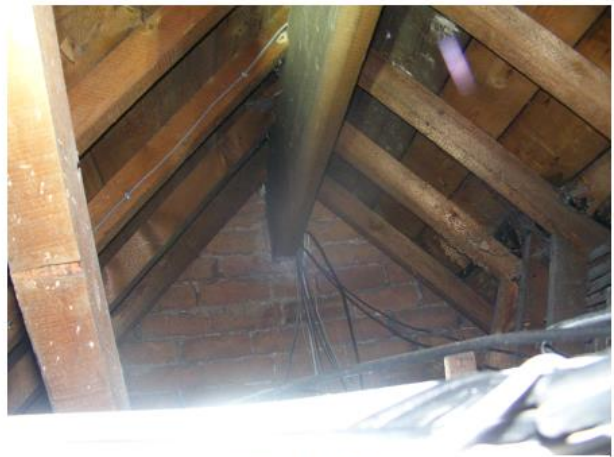
PHOTO 14
Underside of Southern Roof

Only the two main roof voids could be searched and these were sealed and insulated, however, as the remaining part of the building's top floor ceiling, followed the internal contour of the roof, there was no access to the any roof void.

There was a brick-built cellar located beneath the main part of the building with a concrete ceiling, and connected to it was a crawlspace running under the remainder of the building. There was no external access into either part of the cellar, and therefore the cellar offered no bat roosting opportunities (refer to **fig 3** and **photos 1 to 18**, and **20 to 22**).

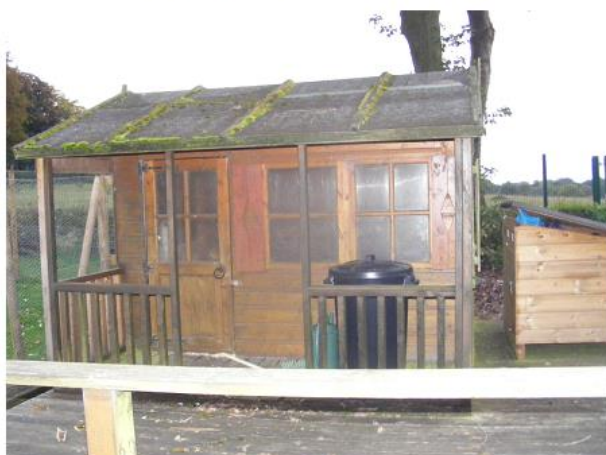
PHOTO 23
Eastern View of Hen House

Positioned close to the western site boundary in the north-western corner of the site was a wooden henhouse. This had been a former Wendy House but at some point, it had been converted for keeping chickens. It was a timber framed construction, with a pitched roof of

uninsulated felt, and with some of its windows still attached, however, the building was partly open at the rear to allow access for the chickens. All parts of the building had neither lining, nor insulation, and frost and extreme ranges in temperature are likely to penetrate the interior, and therefore, the structure offered negligible potential for either hibernating or roosting bats, (refer to **figs 3 and 4**, and **photo 23**).

No evidence of bats was detected in, on, or around any part of the building, nor was any evidence to suggest that the building was being used by either nesting or roosting birds other than chickens.
