Summer Flooding 2012

Environment Agency Report for the Overview & Scrutiny Group – Blackburn with Darwen Borough Council

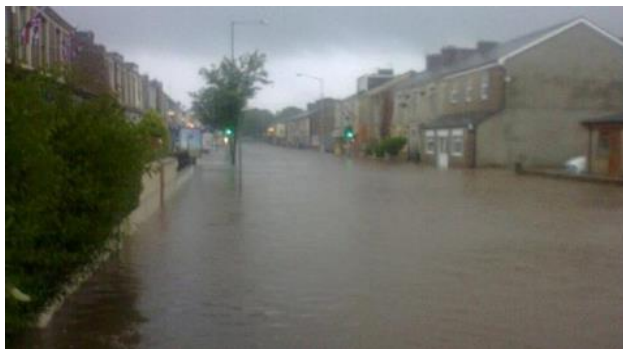
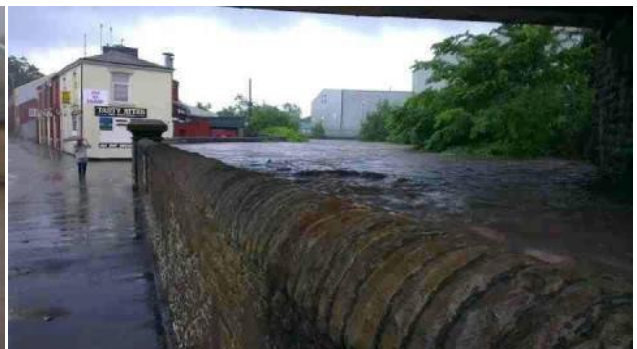
River levels responded rapidly to the heavy rainfall, particularly following the most intense period of rainfall on Friday evening. Record river levels were reached on the upper River Irwell in the Bacup and Rawtenstall areas. We recorded the highest river levels in 20 years on the river Darwen in the Darwen area.

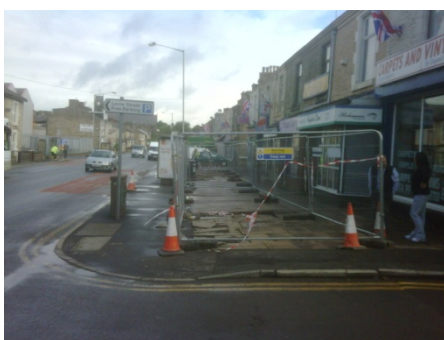
4.1 Clarence Street Culvert, Shorey Bank

A culvert partially collapsed, holding back water which over-topped river walls and flooded property in the Blackburn Road and Duckworth Street. Urgent repair works are ongoing at a cost of £460k. The Clarence Street culvert, which carries the River Darwen, experienced a blockage and partial collapse. This to be 240 metres downstream of the culvert entrance where service pipes run across it - the culvert is over 500 metres long and working conditions are difficult.
