Environmental Visual Audit

Blackburn, Lancashire

On Friday 17th November 2022, An Environmental Visual Audit was conducted in support of Safer Streets 4 on three Lower Super Output Areas (LSOA) (A) E01012632, (B) E01012630, and (C) E01012573.

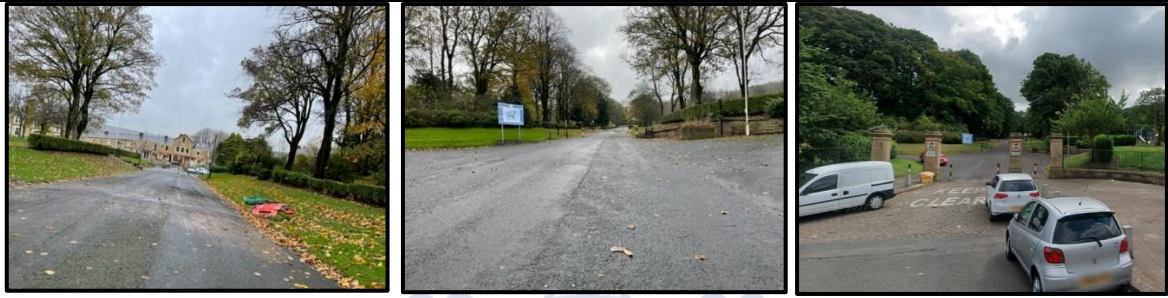
The main pedestrian entrance into the park is to the Northwest elevation off Queens Road which is overlooked by residential properties and a primary school as can be seen in the below images which show the view looking both into, and out of the park at this point, along with a Google Street view image of the entrance.

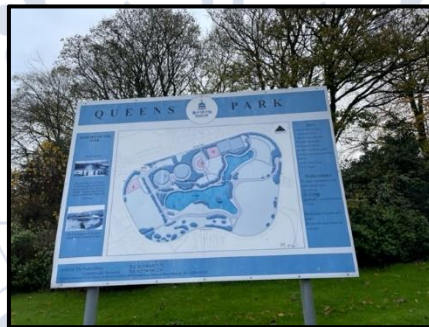
On entering the park here, there was a large map for visitor convenience. This was however the only signage I noticed within the park so opportunities for rule setting and positive ownership display are missed here.

graffiti signage fitted to either dedicated on site sign poles or other structures using tamper-proof fixings to prevent damage or removal of the signs. This rule setting will help to set the tone to all users of what is expected and tolerated in the area, and details of how to report incidents and whom to, should be displayed to display clear ownership of areas.

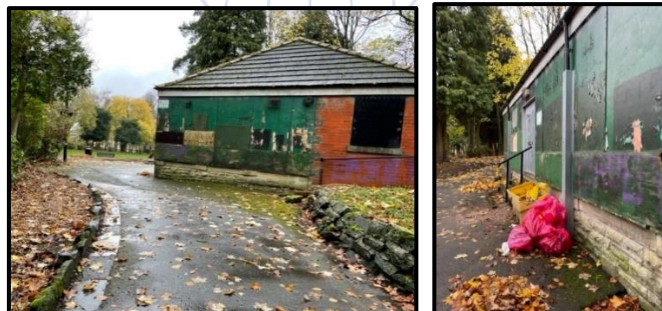
An area identified to me within Queens Park as a hot spot for Anti-Social Behaviour and Drug Dealing incidents was the old bowling green pavilion building. The building has most recently been used by the community payback team and is fully boarded up. There was graffiti and criminal damage evident, and the area was quite secluded within the park with very little lighting, making it an ideal location for those wishing to commit crimes out of sight.

The building could be described as an 'eyesore' in what is a local beauty spot, and its derelict looking nature contributes to the broken windows theory, where visible signs of crime and disorder contributes to further crime and disorder when offenders feel comfortable and safe committing their offences here.

- The Boathouse should be considered for community repurpose, with renovation works and improved security including lighting and cctv as above.
- Similarly, the bowling green and pavilion building should be considered for renovation and community use with improved lighting and cctv coverage also.

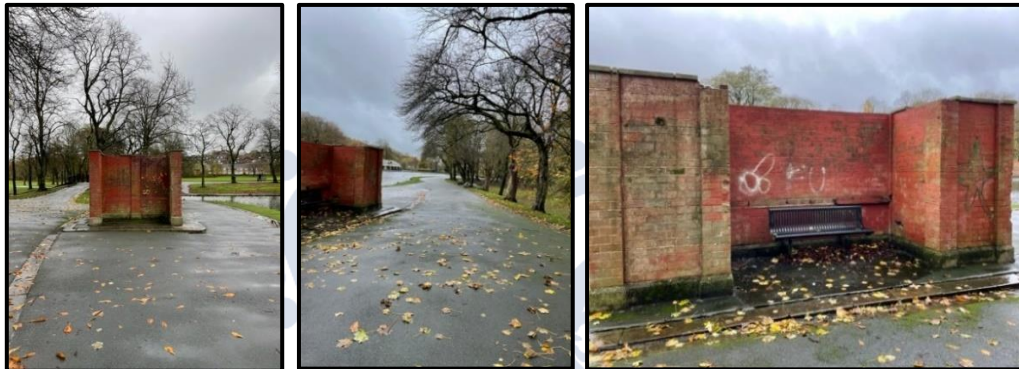
A further area highlighted as problematic at night was an old, roofless, brick-built seating area near to the boating lake as can be seen in the below images. This is the location of the memorial tree mentioned above and can be seen below.

This area is another hotspot for anti-social behaviour and is known to attract congregation by youths and adults committing crimes. Graffiti was present on this structure, including inappropriate paintings, and the design of seating here is set back out of sight, making it an ideal place to hide from view.

- The brick-built seating area near to the boating lake serves no purpose and should be demolished to prevent loitering, concealment, and the associated crimes. If seating is required in the area, pedestal type single seats should be considered as these allow resting but by design discourage lengthy congregation.

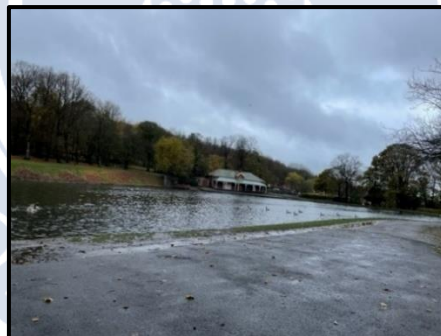
A boathouse was seen to one side of the boating lake. Again, this was not covered by CCTV and featured poor lighting. This space cannot be appropriately utilised due to the fear of crime here and the community use building is at risk of criminal damage and burglary.

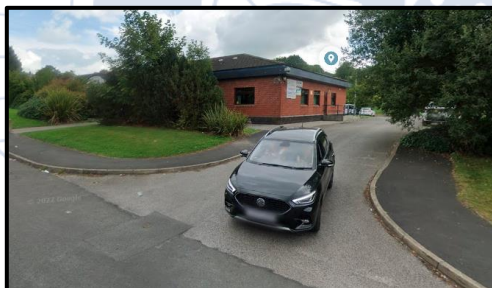
The Queens Park Neighbourhood Learning Centre building and its associated rear car parks were visited first during the EVA of this area as seen in the below Google Maps Images.

This area is a hotspot for anti-social vehicle use and congregation by groups using the centre car park for illegitimate purposes. The area is believed to suffer from drug dealing, drug taking, and groups smoking, vaping, and littering whilst loitering here. A vehicle access prevention barrier is present; however staff choose not to secure this gate after the centre has closed to allow residents parking, however this decision allows the above issues to continue.

A local authority CCTV camera is located to the front of the centre on Pringle Street; however this is the opposite side of the building to the car park so provides limited coverage in the area.

- Staff at the neighbourhood Learning Centre on Pringle Street should secure the vehicular access gates to their car park once the building is closed to prevent this being used for anti-social vehicle use and unlawful congregations.

- Clear signage should be erected in all external areas of the NH Learning Centre to promote rule setting regarding opening hours and acceptable behaviours. Robust aluminium anti-vandal, anti-graffiti signage should be fitted to either dedicated on site sign poles, building walls or other structures using tamper-proof fixings to prevent damage or removal of the signs. This rule setting will help to set the tone to all users of what is expected and tolerated in the area, and details of how to report incidents and whom to, should be displayed to display clear ownership of areas.

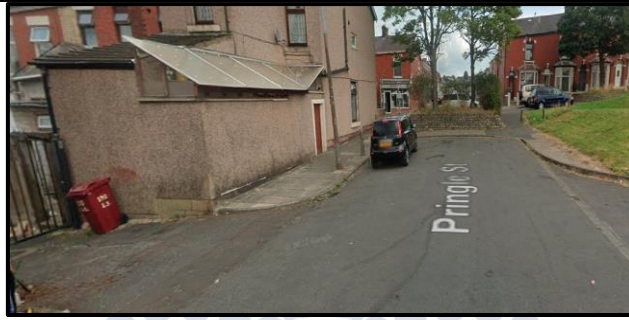
Heading East up Pringle Street a previously open alley way where the rear of properties on Pringle Street and Lambeth Street has been restricted by alley gates. This area is believed to be a hotspot for drug dealing. A concrete and stone mound at the end of Pringle Street is planted with trees and shrubbery and its height obstructs natural and passing surveillance from Lambeth Street. Windblown litter gathers here making it look untidy and unmaintained. This, coupled with the green space adjacent, isolates the area and makes it an ideal location for such unlawful behaviour as can be seen in the below image.

- The concrete and stone mound at the end of Pringle Street (Junction with Lambeth St) should be considered for removal and replaced by vehicle prevention bollards or low planters which prevent vehicle access but allow natural surveillance into the area from surrounding streets. If this is not viable, trees and shrubbery should be maintained so that branches do not overhang, and shrubbery allows natural sightlines without causing visual obstruction for pedestrians and vehicle users. Opening up this area will make it less attractive for criminals to loiter and deal drugs etc.

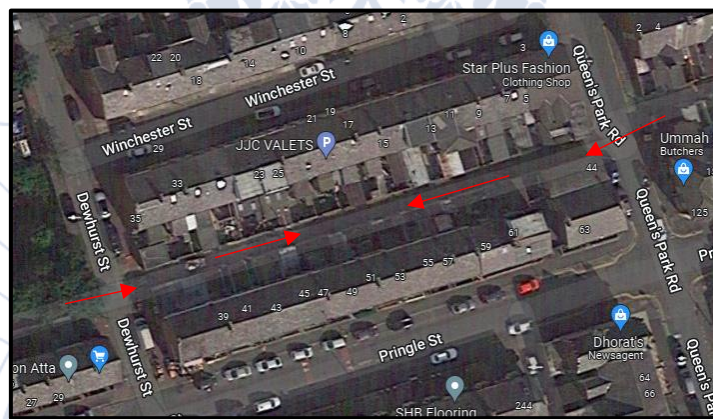
A shared alleyway to the rear of both Pringle Street and Winchester Street was identified as a hotspot area for anti-social behaviour and drug dealing activity. There was evidence of fly tipping in this location. This alleyway was devoid of any alley gates and allows permeability from Dewhurst Street to Queens Park Road without obstruction, as identified on the below Google Images Map.

- A lockable alley gate would be beneficial to the rear of Pringle Street and Winchester Street to prevent excessive permeation and unlawful access between Dewhurst Street to Queens Park Road.

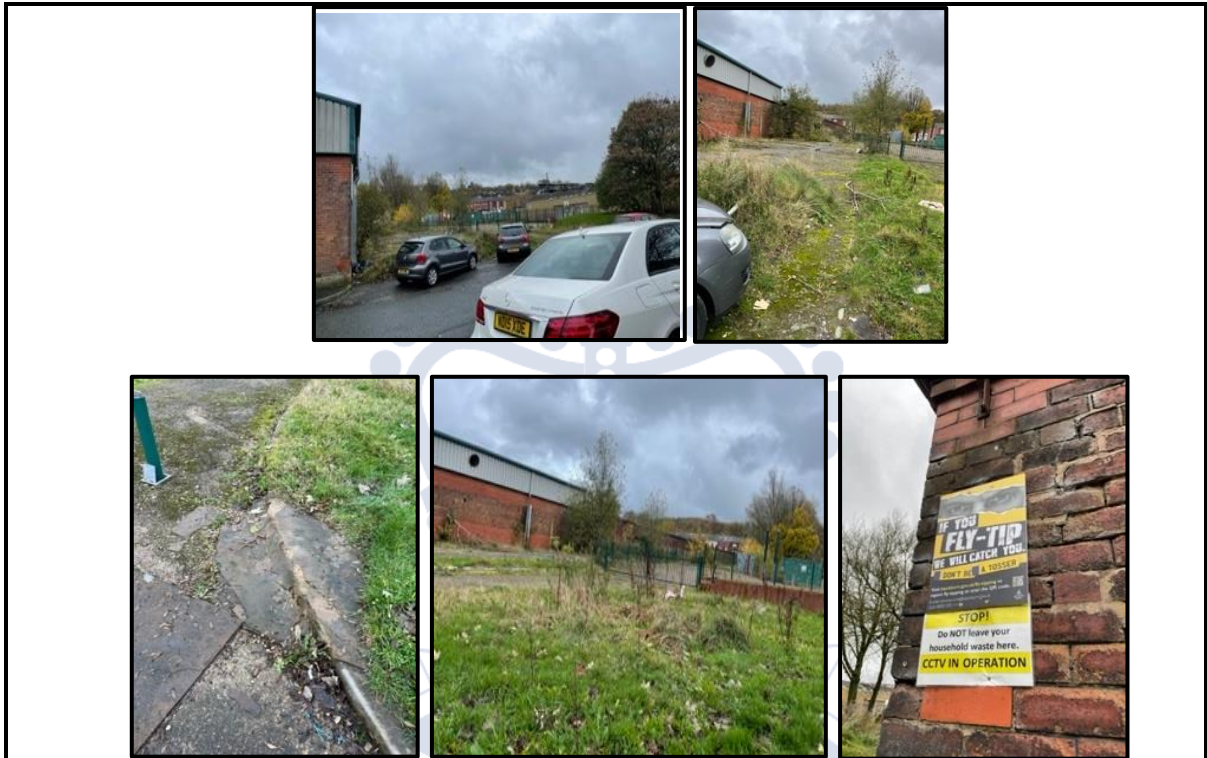
This area has suffered from repeated instances of fly tipping, litter, abandoned vehicles, and damaged street furniture, which was evident during the EVA to the entrance to a children’s playpark and Multi-Use Games Arena as seen below. Signage warning against fly-tipping was visible on a wall on the Dickens street side of the park.

- Dombrey Street would benefit from improved road surfacing and markings, with clear signage erected regarding fly tipping and vehicle parking to promote order and encourage legitimate and appropriate use of the area. Fly tipping should be cleared from this area and landscaping well maintained.

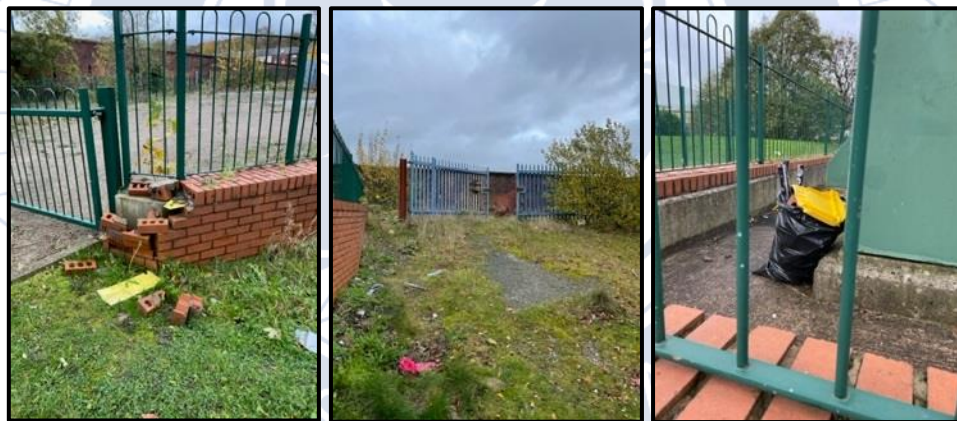
Entry was possible into the grounds of neighbouring industrial structures via insecure gates as seen below, posing a risk to youngsters and anyone else who may stray into these zones. This access is also believed to be exploited by criminals and prostitutes. Anti-social behaviour is commonplace here, and used fireworks littered the area during the visit.

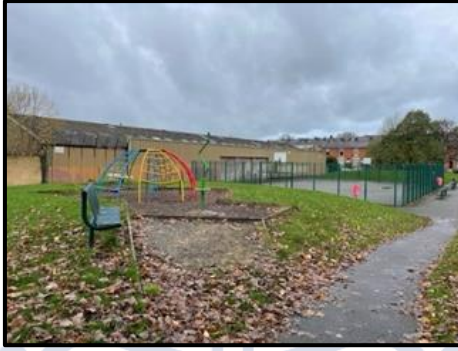
The MUGA and playpark area sit between Pringle Street and Dickens Street, in a patch of land between the industrial units. Whilst this is an excellent amenity for the community, its isolated nature, and lack of any lighting or CCTV mean it cannot be legitimately used after dark. This area is known to be used for drug dealing and other drugs activity, and there have been numerous drug-related arrests made by Police here. An isolated footpath to the rear of the MUGA leading between Pringle Street and Dickens Street is particularly problematic and provides a transport route on foot out of sight from criminal activity.

- The MUGA and children's park between Dombrey Street and Pringle Street are look worn and dated, and whilst these are a great facility for children and youths in the area, they would benefit from aesthetic maintenance and damage repair to promote feelings of ownership and responsibility here. Areas which fall into disrepair, with peeling paint and rust contribute to the 'Broken Window Theory' giving the impression that it is not looked after and making them a comfortable place to offend.

- Lighting improvements would benefit the MUGA and children's park areas to increase feelings of safety. Clear signage should be erected to promote rule setting and outline expectations of users of the sites.

- The MUGA and children's park area would benefit from increased numbers of local authority monitored CCTV cameras to promote feelings of safety and deter crimes such as ASB and Violent crimes here, whilst supporting the identification of offenders. An area identified as the best location for a camera here was on the Dickens Street elevation.

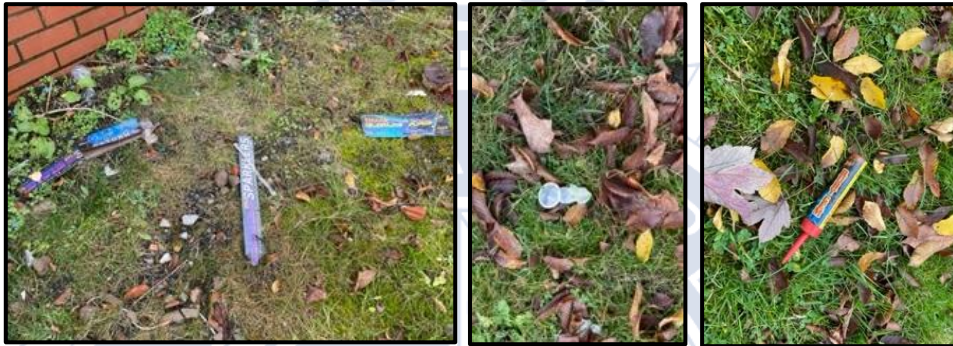
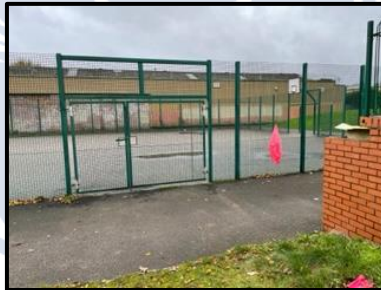
Evidence of further used fireworks and condoms were seen around the park area, confirming anti-social behaviour and sexual activity occurring in the area, and a divan bed base was seen dumped in adjacent scrubland. There has been an issue of vehicles being abandoned on this land, and the local authority has now added a mound of earth to prevent vehicle access. Local Authority red bin bags were seen tied to the sides of the MUGA, in the absence of dedicated litter bins here, which can be seen in the below images.

- New litter bins/ dog waste bins should be introduced to the MUGA and Playpark area and entrances to encourage responsible disposal of litter. These should be emptied regularly to prevent overflowing. Bins should be of fire-proof design and construction to prevent the risk of arson here.

- The area of damaged wall to the United Utilities substation land next to the MUGA should be repaired expeditiously to prevent further damage, and prevent bricks being used as missiles here. Proper maintenance will display positive management and maintenance here which can help to deter crimes.

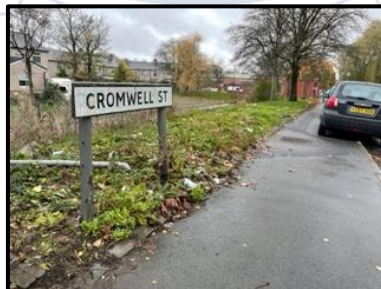
An area further East of the MUGA within the LSOA was identified to me on Cromwell Street as seen below. This area has recently had a number of garages demolished and cleared due to drug dealing and anti-social behaviour, though this is still believed to occur in the derelict space. This area was devoid of lighting columns, was in poor repair and felt like an area to avoid.

- The former garage clearing on Cromwell Street is believed to have been sold or is being sold. This is positive and a new use for the area will remove its availability for crime.

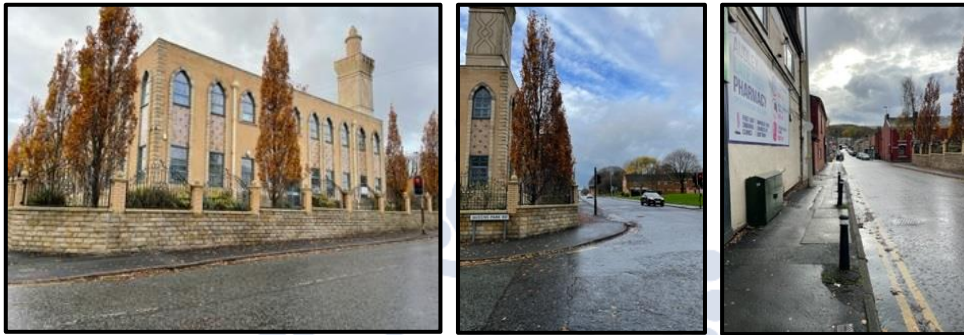
A local resident spoken to during the EVA, raised concerns regarding gang congregation and drug dealing from vehicles around the Walter Street and Queens Park Road area near to the shops and Masjide Noorul

Islam Mosque on Audley Range. Such behaviour is believed to occur daily, with vehicles blocking footpaths and is intimidating and worrying for local residents and the mosque community who fear for their safety.

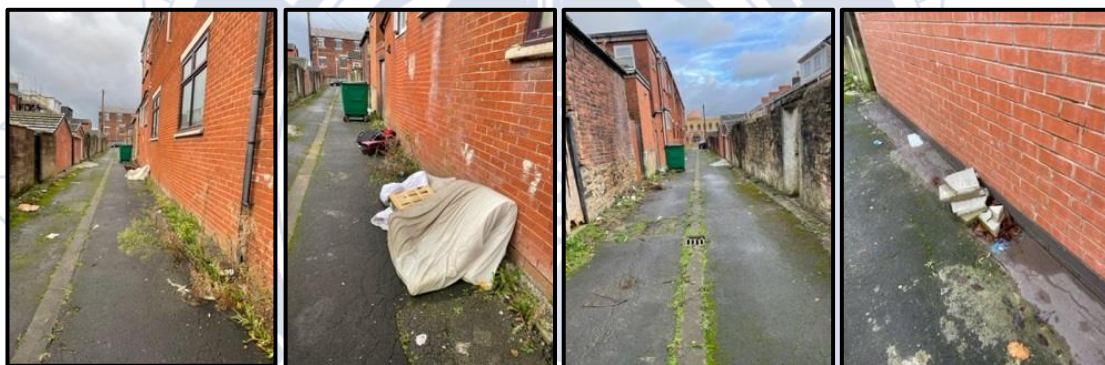
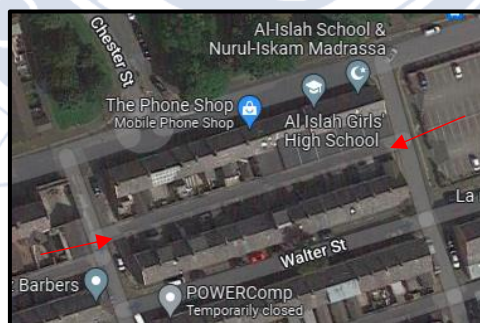
The Madrassa Nooral Islam Girls School is located next door to the Masjide Noorul Islam Mosque on Audley Range, and features an unrestricted alleyway to the rear, shared with neighbouring businesses and also residential properties to the rear on Walter Street. This alleyway connects Dewhurst Road with an extension of Chester Close. This alleyway was identified as problematic for drug dealing and anti-social behaviour and is used as a 'rat run' to the rear of shops and dwellings here. Evidence of litter and fly tipping was seen (as shown below), and the area did not feature any lighting so is known to be very dark during the evenings making it the ideal location to commit crime.

- Lockable alley gates should be considered for the rear alley behind The Madrassa Nooral Islam Girls School on Audley Range to prevent unrestricted access between Dewhurst Road and Chester Close.

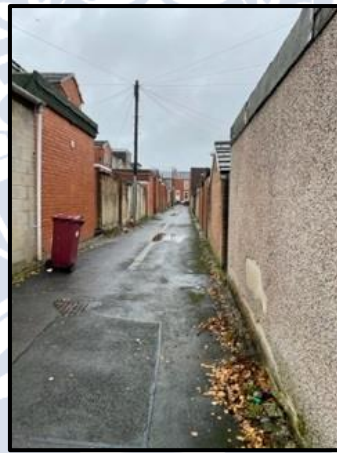
Alleyways around Walter Street were in general identified by the NH Policing Team as being hotspots for drug dealing activity and loitering in the early hours of the morning, making residents feel unsafe within their homes and in the neighbourhood.

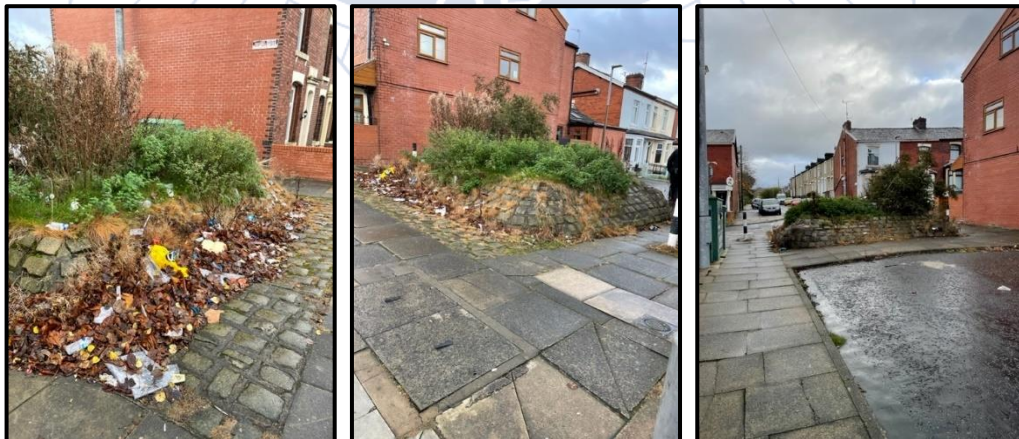
Lambeth Street was the first section of this LSOA covered during the EVA, and as with the junction of Pringle Street, a concrete and stone mound at the junction of Ripon Street was overgrown and obstructed sight lines into the area. Again, leaves and windblown litter congregated here making the area look unsightly as can be seen in the below images. A lack of litter bins in the area contribute to this problem.

- The concrete and stone mound at the end of Ripon Street (Junction with Lambeth St) should be considered for removal and replaced by vehicle prevention bollards or low planters which prevent vehicle access but allow natural surveillance into the area from surrounding streets. If this is not viable, trees and shrubbery should be maintained so that branches do not overhang, and shrubbery allows natural sightlines without causing visual obstruction for pedestrians and vehicle users.

- New litter bins/ dog waste bins should be introduced to the Lambeth Street area to encourage responsible disposal of litter. These should be emptied regularly to prevent overflowing. Bins should be of fire-proof design and construction to prevent the risk of arson here.

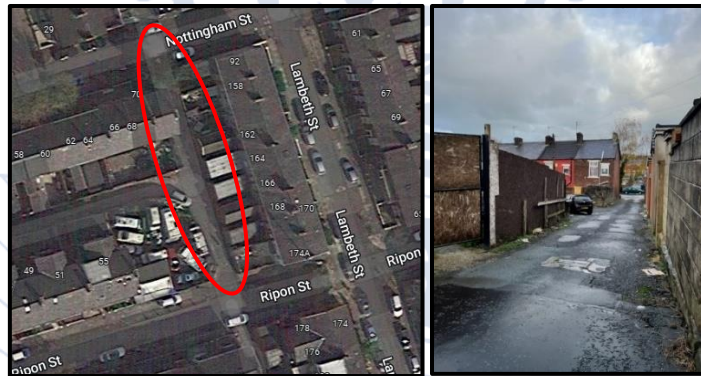
An alleyway to the rear of properties on Lambeth Street, joining Ripon Street with Nottingham Street was identified as another hotspot for criminality. This alleyway is wide enough for vehicles to access and is used by local drug dealers as a cut-through between the streets, allowing them to travel around easily without being seen or caught. Drug dealers are believed to congregate here, and one resident has erected a high fence to protect their property.

- Lockable alley gates should be considered for the two identified (as detailed above) rear alleyways behind Lambeth Street (connecting Ripon St with Nottingham Street). Consideration should be given to ensuring this would not interfere with the new proposed development on adjacent land.

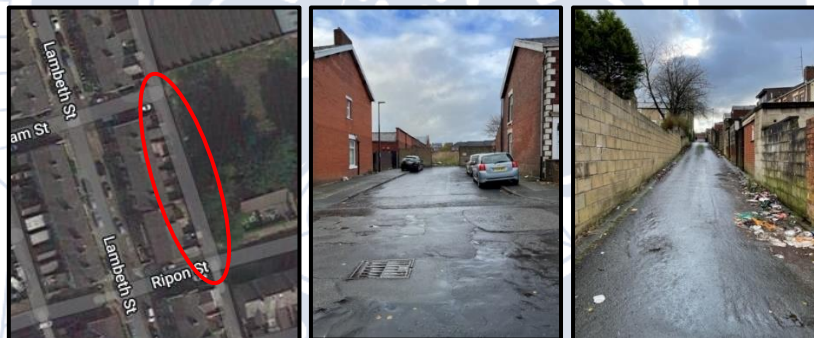
Another area off Lambeth Street with the junction of Ripon Street / Nottingham street as shown in the below Google Maps and EVA images, was identified as a hotspot for fly tipping and vehicle abandonment. Alleysways to the rear of properties here are used as 'rat runs' by criminals travelling out of sight, and the access point is not overlooked by surrounding properties. This particular alleyway leads to another section of Ripon Street.

A lack of cctv and lighting here means the area is extremely dark at night and one resident has retrofitted their own cctv cameras to the rear of their property, at the alleyway location.

- The junction of Lambeth Street with Nottingham Street would benefit from local authority monitored CCTV cameras to promote feelings of safety and deter crimes such as ASB, drug dealing and fly tipping whilst supporting the identification of offenders.

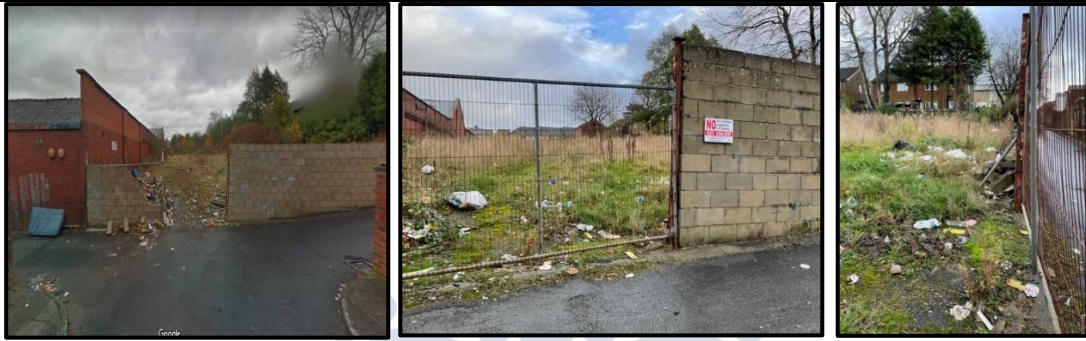
The adjacent patch of currently disused land has become the main target for fly tipping here as shown in the below images, however a notice was seen at the time on a nearby lamppost suggesting that a planning application has been submitted (Ref 10/22/0166) for the erection of 9 residential dwellings on the land.

- Clear signage should be erected near to all road junctions / concrete mounds / disused land such as that off Lambeth St / Nottingham street to promote rule setting and outlining acceptable behaviours here such as no fly tipping. Signage regarding the presence of CCTV should also be present. Signage should be of robust aluminium anti-vandal, anti-graffiti construction, fitted to either dedicated sign poles, walls or fence perimeters using tamper-proof fixings to prevent damage or removal. This rule setting will help to set the tone for users from the outset that security and safety in the area is taken seriously, assisting in crime prevention where offenders feel they are being watched.

- Fly tipping should be cleared from rear alleyways, with consideration of a community skip day where residents can responsibly dispose of waste and furniture items into skips to prevent them ending up in alleyways.

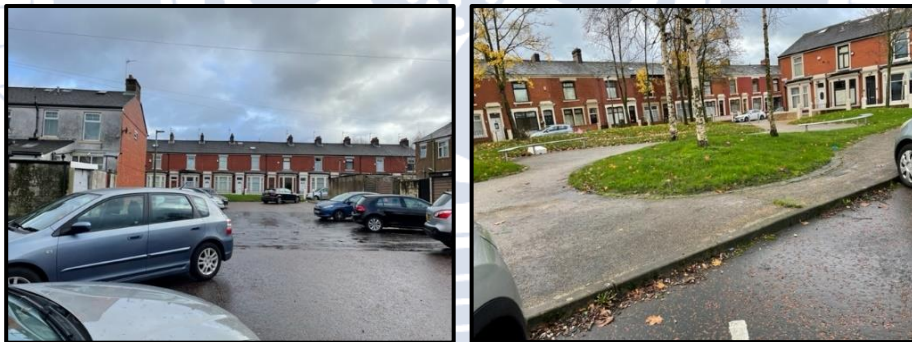
This car park has been problematic for residents due to vehicle abandonment, drug dealing, and vehicles being parked here out of sight, which are used to store quantities of drugs. Police have recovered drugs from vehicles here and the local neighbourhood policing team are aware of and have been targeting drug dealing and other criminality in this car park.

There was no cctv in this location, and very little lighting, most of which would be borrowed light from the adjacent street lighting columns on June, July and Nottingham Streets surrounding the car park.

- The June/July Street resident's car park should also feature warning signage and would benefit from increased lighting and Local Authority Monitored CCTV cameras to deter against drug dealing and loitering, whilst supporting the identification of offenders.
