# DEMOLITION PHASE HEALTH SAFETY & ENVIRONMENTAL PLAN

## HIGHER HOUSE FARM BLACKAMOOR

## Demolition Phase Health, Safety & Environmental Plan

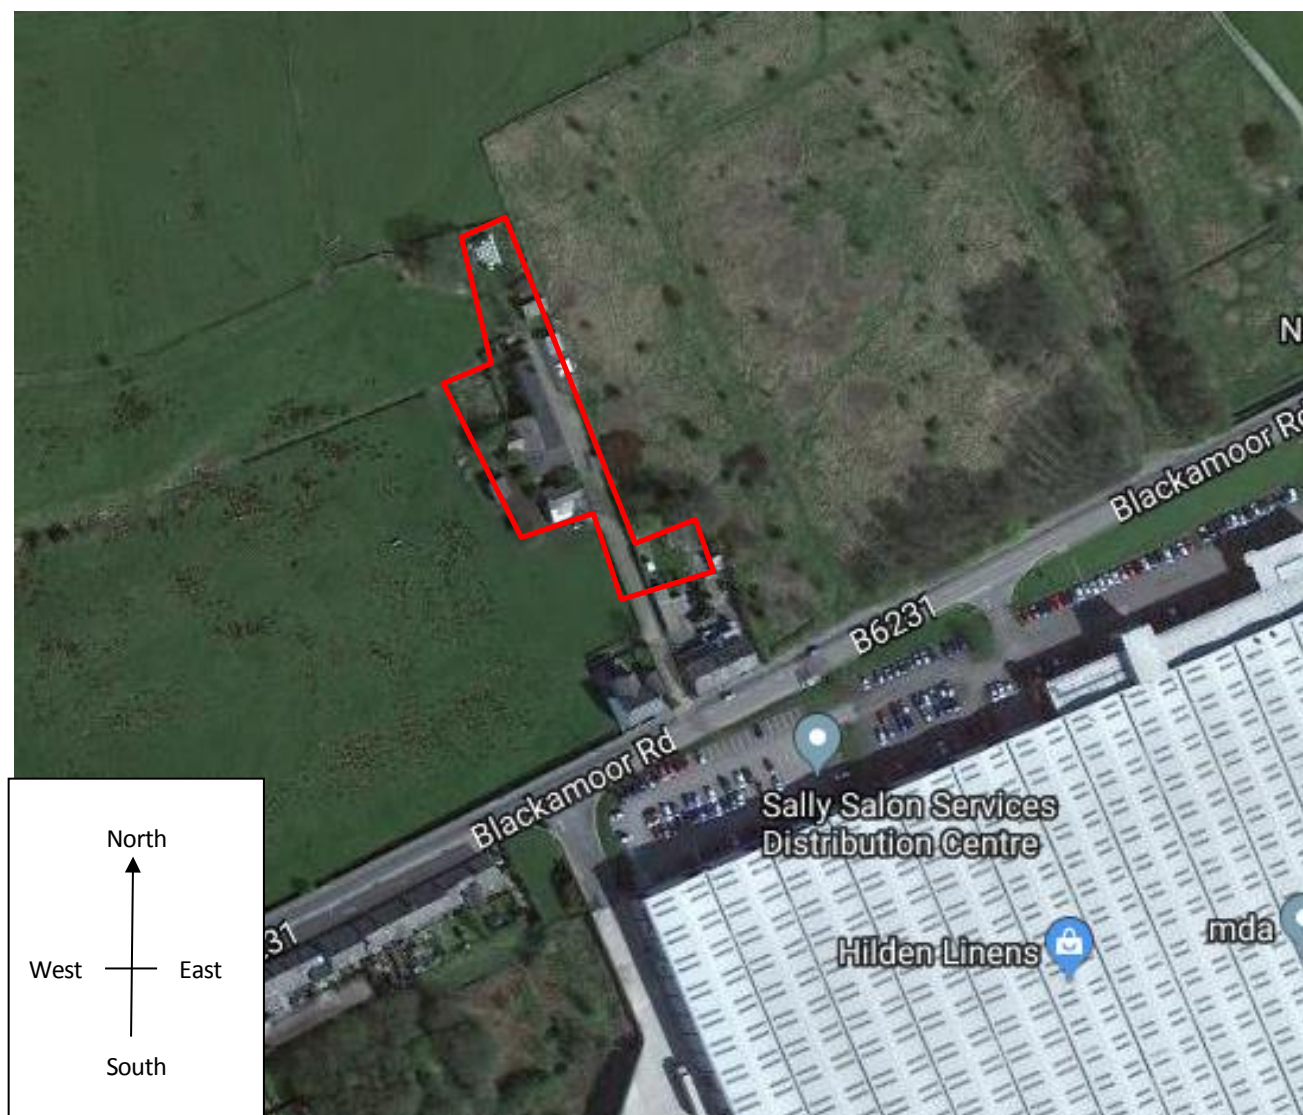
**Note:** there is a farmers track running through the middle of the site. All gates leading into fields are to be closed at all times.

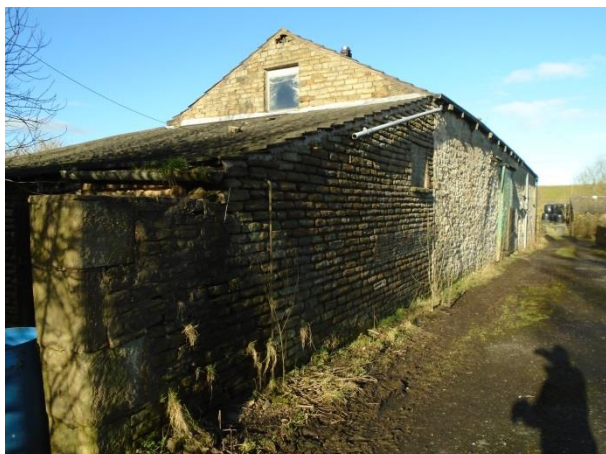
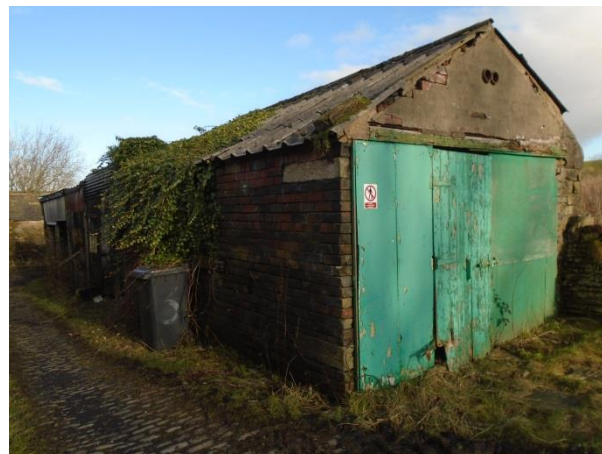
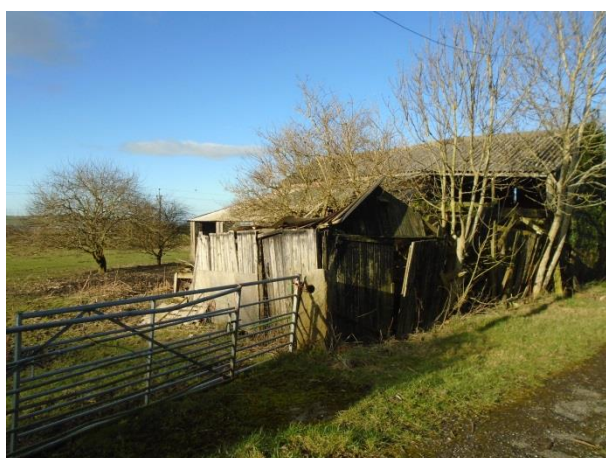
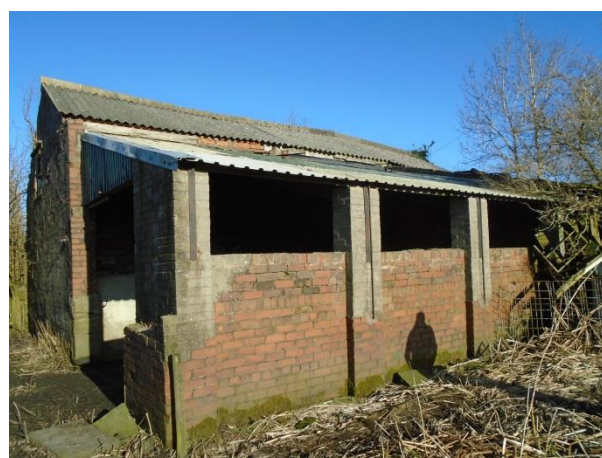
- The main farmhouse is two storey and is traditionally constructed from stone and/or brick. The roof is wooden pitched covered with roofing tiles. Single storey extensions have been added to the structure over the years.
- The outbuildings are all single storey constructed from either stone, brick, wood or tin profile sheeting. The roofs are pitched and covered with either asbestos cement, slates, tiles or metal cladding.
- Many of the outbuildings are in a bad state of repair and access into them will be prohibited. FDL Site Manager will highlight in the site induction the buildings that are dangerous to access.
- There is a water well within one of the structures.

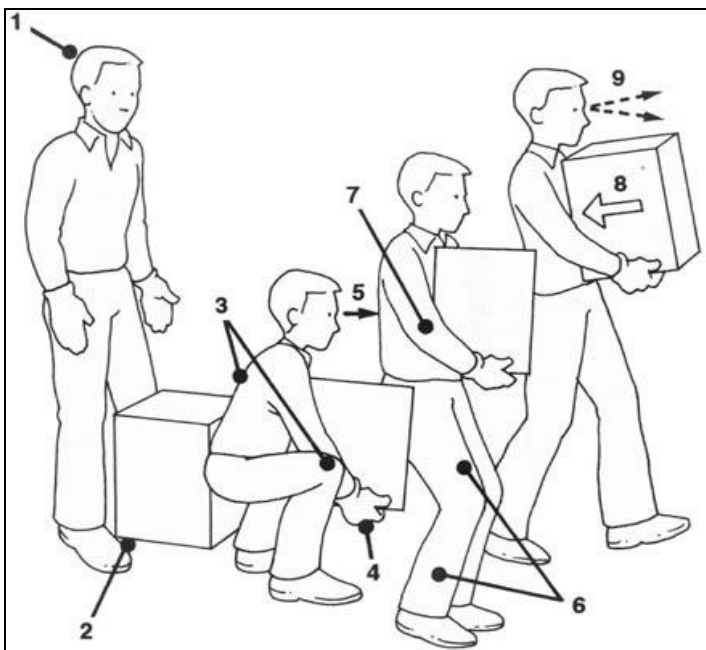
**Figure 1**

- When lifting always use the correct kinetic method of lifting as shown in **figure 1**;

Kinetic lifting technique;

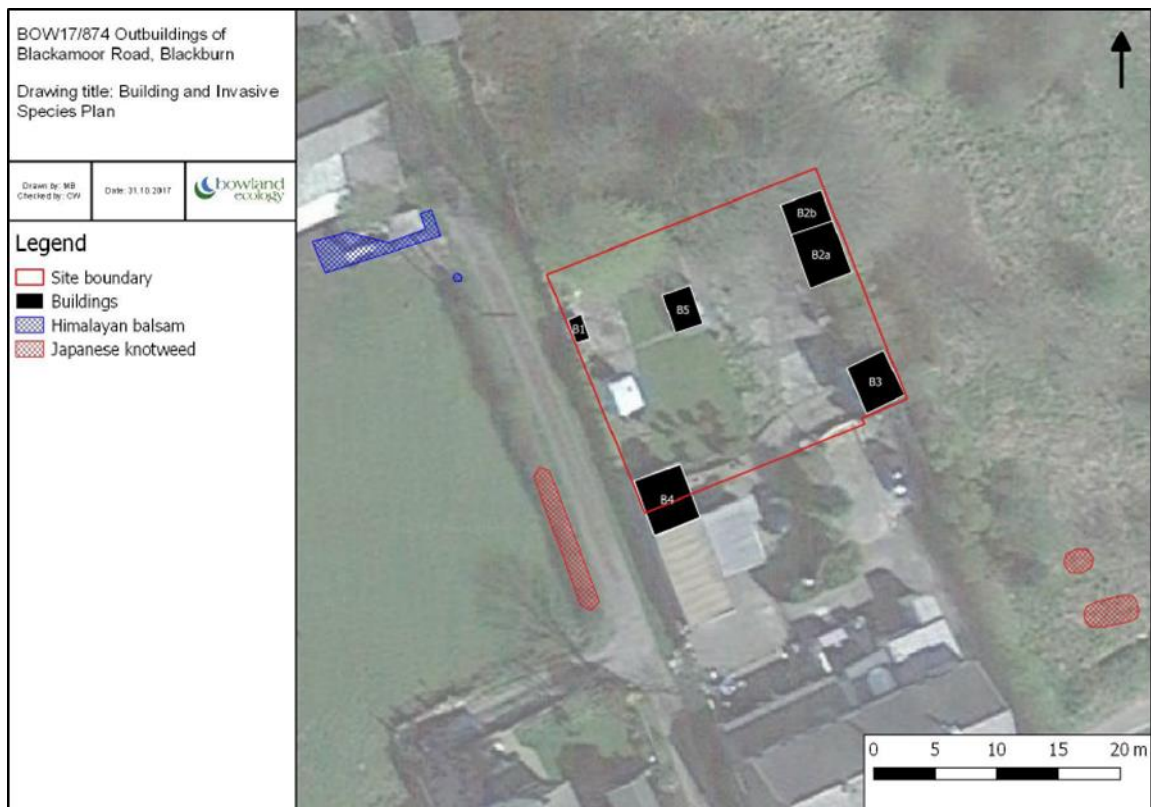
A2.1 Orange netted fencing will be erected around areas where invasive species have been identified. Access into these areas by foot or plant equipment will be prohibited. See plan below for details of contaminated areas.

A2.3 The location of the 450mm culvert will be identified and fenced using orange netting.

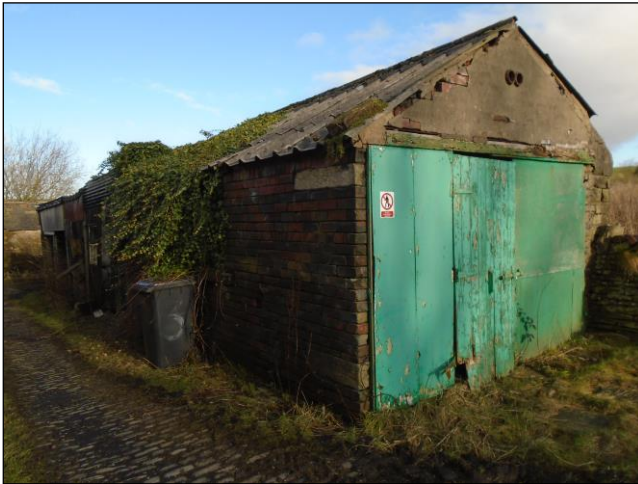
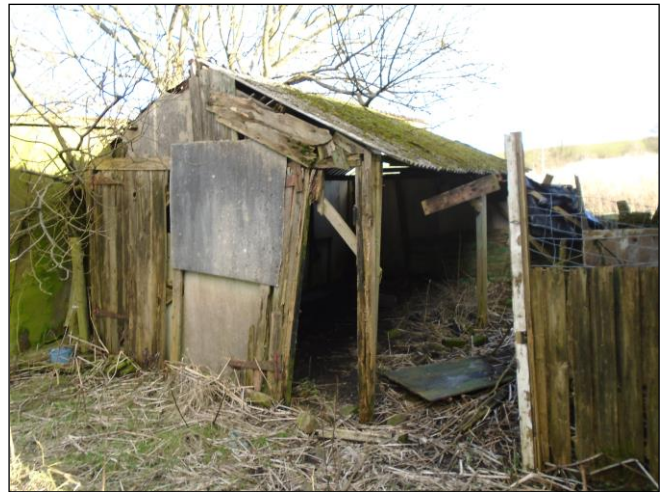
- A3.1 Access into the some of the outbuildings will be prohibited due to the poor state of repair. A 360° excavator fitted with a demolition grab will be utilised to demolish the structures. All excavator operators will carry out daily recorded 'pre-use' checks of excavator, quick hitch and attachments.

- A3.2 The buildings will be demolished commencing from the gable elevation working towards the opposite gable elevation. The excavator will sit within the footprint of the structure as soon as practicable.

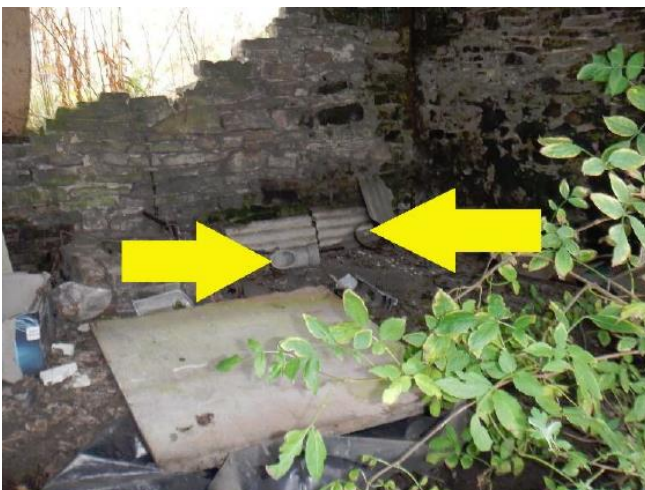
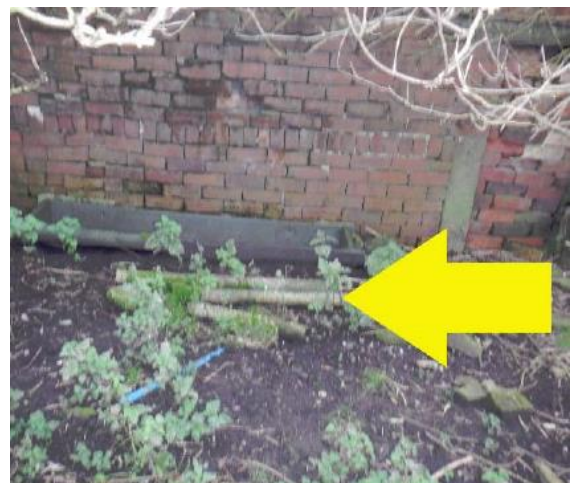
#### *Asbestos cement debris*

A3.4 The asbestos cement debris will be handpicked and placed directly into asbestos bags.

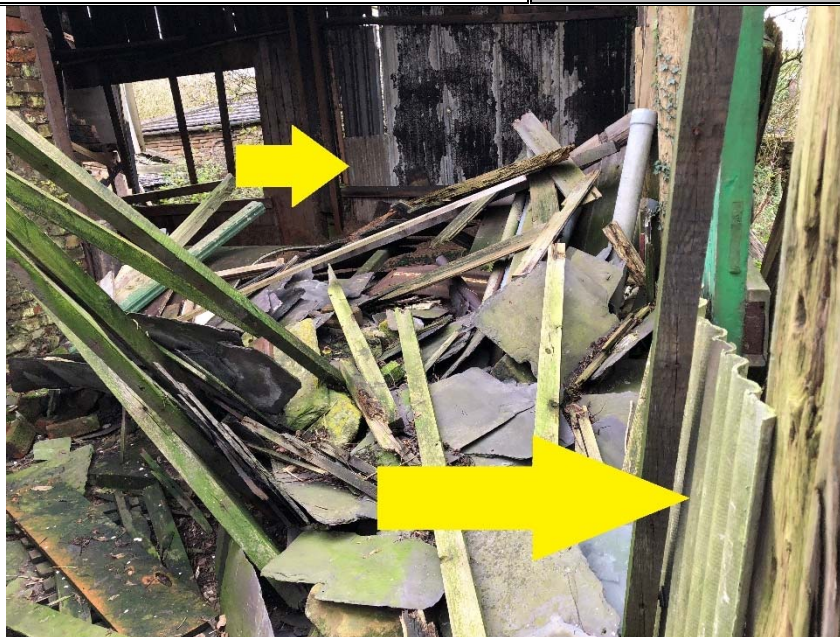
Sample Number	Known Asbestos/1 (confirmed by the surveyor)	Material Risk Assessment (Refer to bottom of page for additional information)		
	<b>Product/Material Description:</b>	*Internal/External	Internal/external	
	<b>Asbestos cement wall panels (Approx 2.5 Sqm). Further amounts of associated asbestos cement may be found within the general debris in the surrounding area</b>	Product/Material	A/C	
		*Asbestos Type	Chrysotile (white) asbestos	
		*Condition	Poor condition	
		*Access	High access	
		*Treatment	Composite material	
		Quantity	Approx 2.5 Sqm	
		<b>Total Points:</b>		<b>08</b>
		<b>Risk Assessment Category:</b>		<b>C</b>

<b>Recommendations/Comments:</b>	Remove and dispose of as asbestos waste, prior to demolition. All works with asbestos must be undertaken in accordance with the current asbestos regulations (2012) and it's approved codes of practise.
<b>Remediation/Management Comments:</b>

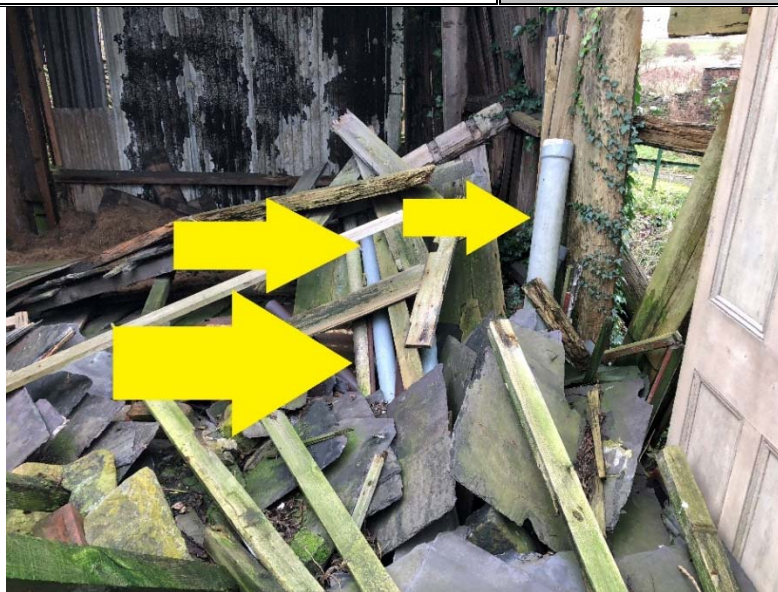
Sample Number	Known Asbestos/2 (confirmed by the surveyor)	Material Risk Assessment (Refer to bottom of page for additional information)		
	<b>Product/Material Description:</b>	*Internal/External	Internal/external	1
	<p><b>Asbestos cement tubes, mixed in with general rubble/debris (full extent unknown)</b></p>	Product/Material	A/C	0
		*Asbestos Type	Chrysotile (white) asbestos	1
		*Condition	Poor condition	4
		*Access	High access	1
		*Treatment	Composite material	0
		Quantity	Full extent unknown, mixed with general rubbish	
		<b>Total Points:</b>		<b>08</b>
		<b>Risk Assessment Category:</b>		<b>C</b>

<b>Recommendations/Comments:</b>	Remove and dispose of as asbestos waste, prior to demolition. All works with asbestos must be undertaken in accordance with the current asbestos regulations (2012) and it's approved codes of practise.
<b>Remediation/Management Comments:</b>

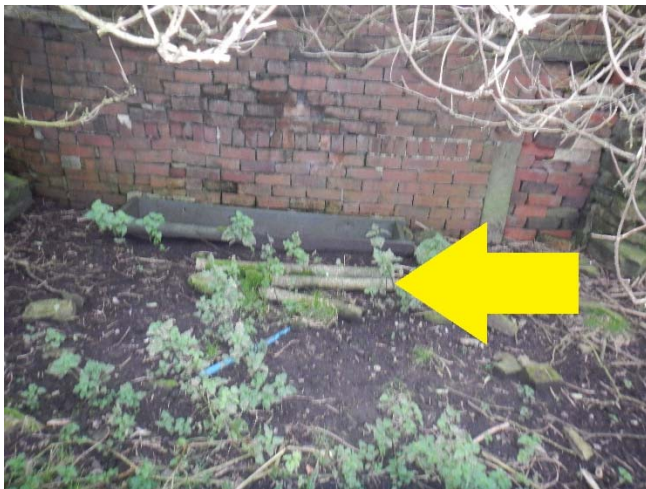
Sample Number	Known Asbestos/4 (confirmed by the surveyor)	Material Risk Assessment (Refer to bottom of page for additional information)		
	<b>Product/Material Description:</b>	*Internal/External	Internal/external	
	<b>Loose asbestos cement corrugated sheets and A/C tubes to the external ground</b>		1	
		Product/Material	A/C	0
		*Asbestos Type	Chrysotile (white) asbestos	1
		*Condition	Poor condition	4
		*Access	High/limited access	1
		*Treatment	Composite material	0
		Quantity	Full extent unknown, cant access G13	
			<b>Total Points:</b>	<b>08</b>
		<b>Risk Assessment Category:</b>	<b>C</b>

<b>Recommendations/Comments:</b>	Remove and dispose of as asbestos waste, prior to demolition. All works with asbestos must be undertaken in accordance with the current asbestos regulations (2012) and it's approved codes of practise.
<b>Remediation/Management Comments:</b>

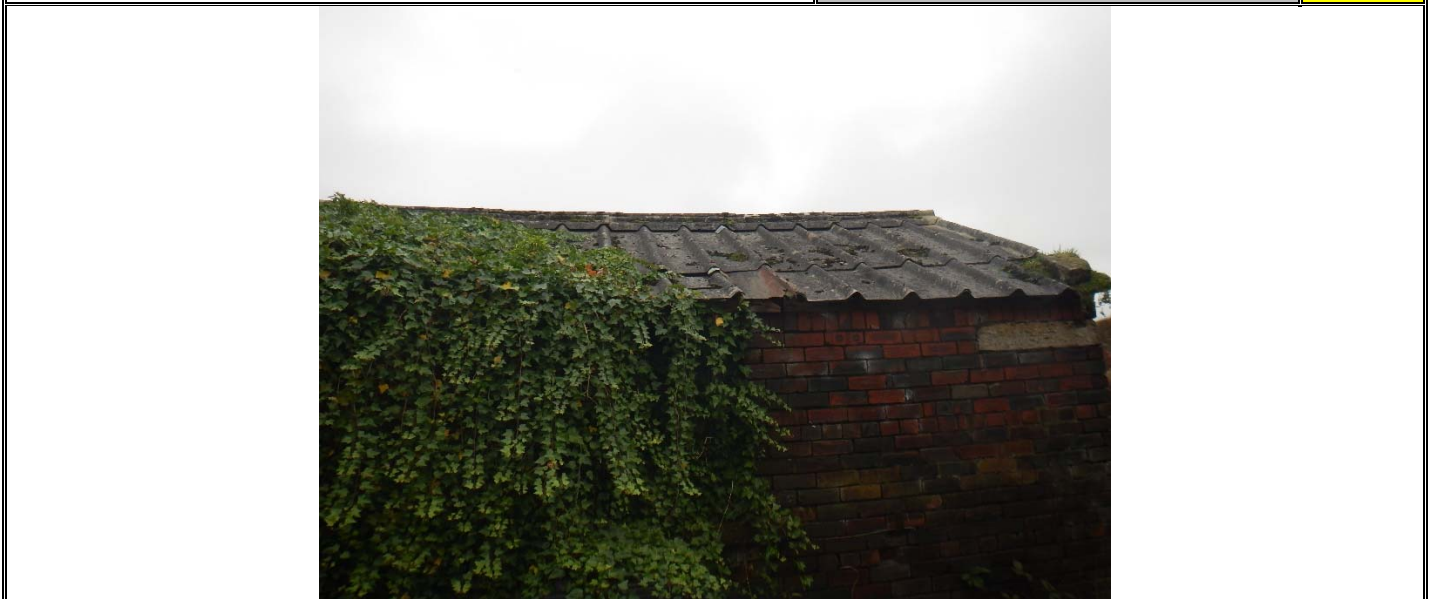
Sample Number	Sample FB/11	Material Risk Assessment (Refer to bottom of page for additional information)			
<b>Product/Material Description:</b>		*Internal/External	Internal/external	1	
<b>Asbestos cement (A/C) roof sheets</b>		Product/Material	A/C	0	
		*Asbestos Type	Chrysotile (white) asbestos	1	
		*Condition	Medium condition	2	
		*Access	Medium access	1	
		*Treatment	Composite material	0	
		Quantity	Approx 20 Sqm		
		<b>Total Points:</b>			<b>05</b>
<b>Risk Assessment Category:</b>			<b>D</b>

<b>Recommendations/Comments:</b>	Remove and dispose of as asbestos waste, prior to demolition. All works with asbestos must be undertaken in accordance with the current asbestos regulations (2012) and it's approved codes of practise.
<b>Remediation/Management Comments:</b>

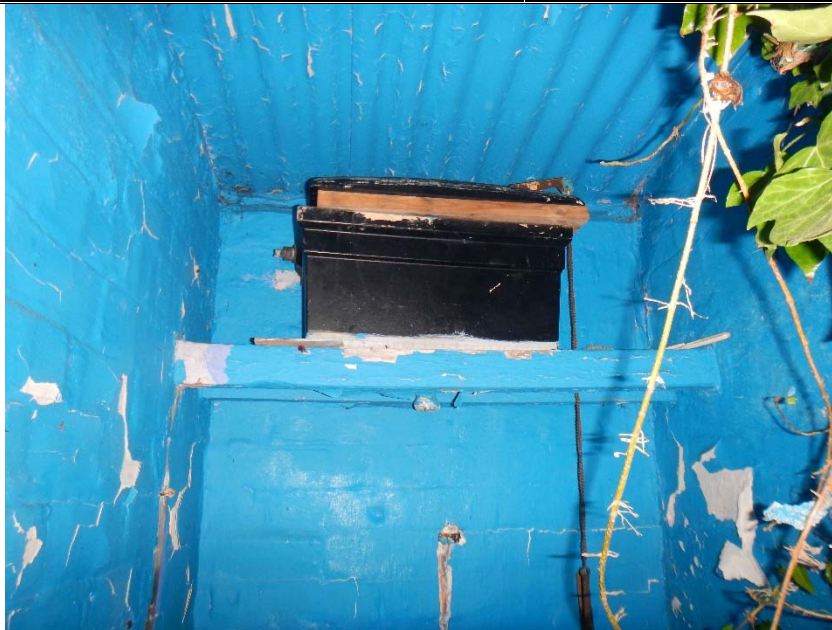
Sample Number	Known Asbestos/5 (confirmed by the surveyor)	Material Risk Assessment (Refer to bottom of page for additional information)		
	<b>Product/Material Description:</b>	<b>*Internal/External</b>	Internal/external	<b>1</b>
	<b>Asbestos containing W/C cistern</b>	<b>Product/Material</b>	WC cistern	<b>0</b>
		<b>*Asbestos Type</b>	Amosite (brown) asbestos (Typically)	<b>2</b>
		<b>*Condition</b>	Good condition	<b>0</b>
		<b>*Access</b>	High access	<b>2</b>
		<b>*Treatment</b>	Composite material	<b>0</b>
		<b>Quantity</b>	X1	
<b>Total Points:</b>				<b>05</b>
<b>Risk Assessment Category:</b>				<b>D</b>

<b>Recommendations/Comments:</b>	Remove and dispose of as asbestos waste, prior to demolition. All works with asbestos must be undertaken in accordance with the current asbestos regulations (2012) and it's approved codes of practise.
<b>Remediation/Management Comments:</b>

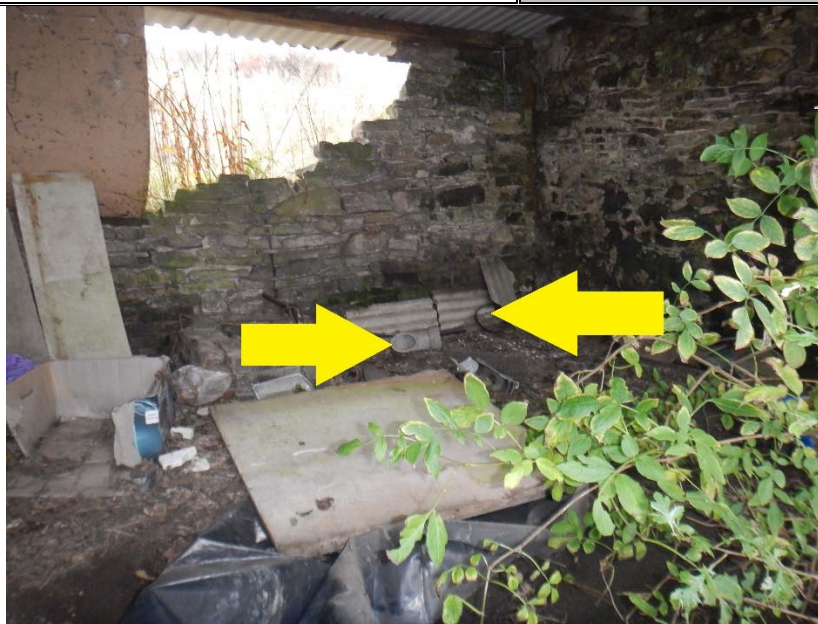
Sample Number	As Sample FB/13(2)	Material Risk Assessment (Refer to bottom of page for additional information)			
<b>Product/Material Description:</b>		<b>*Internal/External</b>	Internal/external		
<b>Loose asbestos (A/C) cement sheets and an A/C tube to the ground (Approx 4 Sqm)</b>		<b>Product/Material</b>	A/C		
		<b>*Asbestos Type</b>	Chrysotile (white) asbestos		
		<b>*Condition</b>	Poor condition		
		<b>*Access</b>	High access		
		<b>*Treatment</b>	Composite material		
		<b>Quantity</b>	Approx 4 Sqm		
		<b>Total Points:</b>		<b>08</b>	
		<b>Risk Assessment Category:</b>		<b>C</b>

<b>Recommendations/Comments:</b>	Remove and dispose of as asbestos waste, prior to demolition. All works with asbestos must be undertaken in accordance with the current asbestos regulations (2012) and it's approved codes of practise.
<b>Remediation/Management Comments:</b>

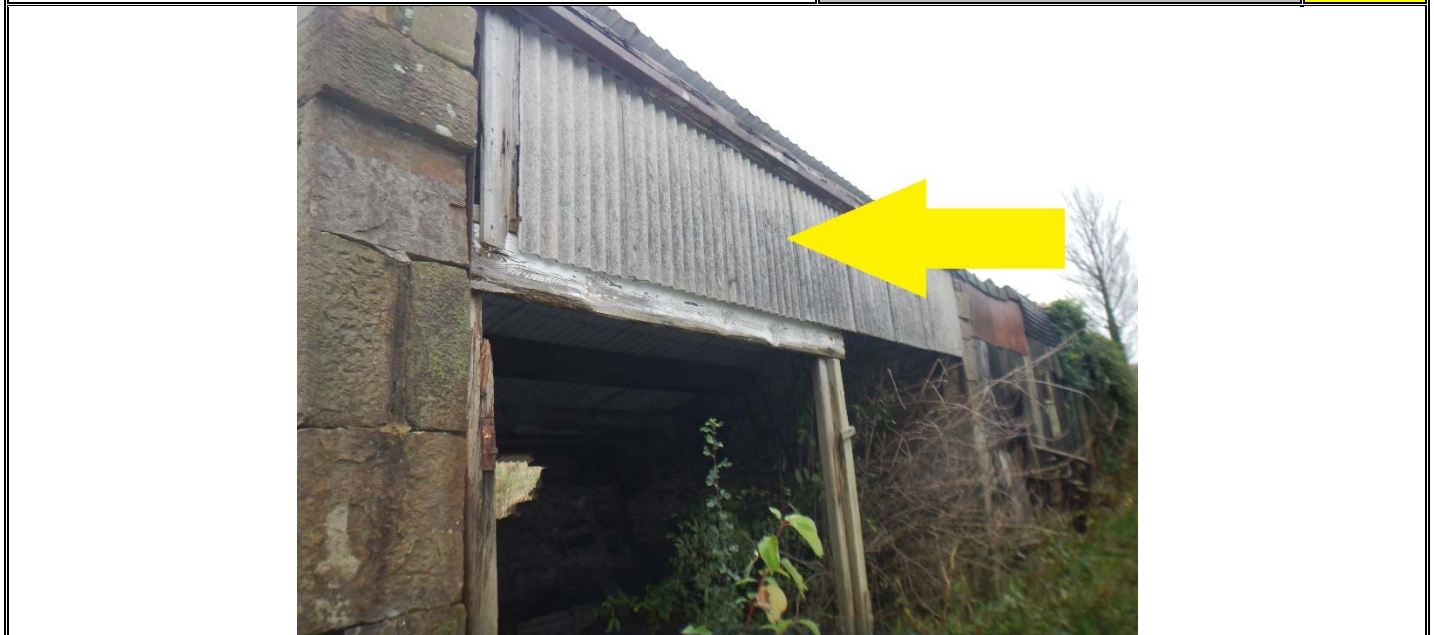
Sample Number	As Sample FB/13(3)	Material Risk Assessment (Refer to bottom of page for additional information)			
<b>Product/Material Description:</b>		*Internal/External	Internal/external		
<b>Asbestos cement (A/C) fascia (Approx 6 Sqm)</b>		Product/Material	A/C		
		*Asbestos Type	Chrysotile (white) asbestos		
		*Condition	Medium condition		
		*Access	High access		
		*Treatment	Composite material		
		Quantity	Approx 6 Sqm		
		<b>Total Points:</b>		<b>06</b>	
		<b>Risk Assessment Category:</b>		<b>C</b>

<b>Recommendations/Comments:</b>	Remove and dispose of as asbestos waste, prior to demolition. All works with asbestos must be undertaken in accordance with the current asbestos regulations (2012) and it's approved codes of practise.
<b>Remediation/Management Comments:</b>

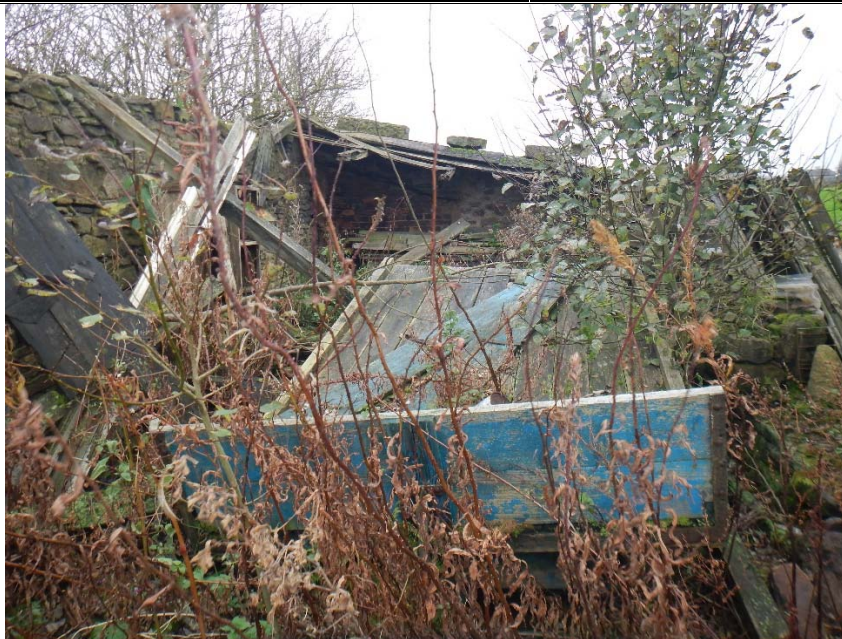
Sample Number	As Sample FB/13(1)	Material Risk Assessment (Refer to bottom of page for additional information)			
<b>Product/Material Description:</b>		*Internal/External	External		
<b>Asbestos cement (A/C) roof sheet debris, mixed in with general debris/overgrowth. The A/C debris is thought to have been the roof of the structure (Approx 20 Sqm)</b>		Product/Material	A/C		
		*Asbestos Type	Chrysotile (white) asbestos		
		*Condition	Poor condition		
		*Access	High access		
		*Treatment	Composite material		
		Quantity	Approx 20 Sqm (Guessed)		
		<b>Total Points:</b>		<b>07</b>	
		<b>Risk Assessment Category:</b>		<b>C</b>

<b>Recommendations/Comments:</b>	Remove and dispose of as asbestos waste, prior to demolition. All works with asbestos must be undertaken in accordance with the current asbestos regulations (2012) and it's approved codes of practise.
<b>Remediation/Management Comments:</b>
