Darwen Three Day Market Demolition

Flood Risk Assessment
June 2017

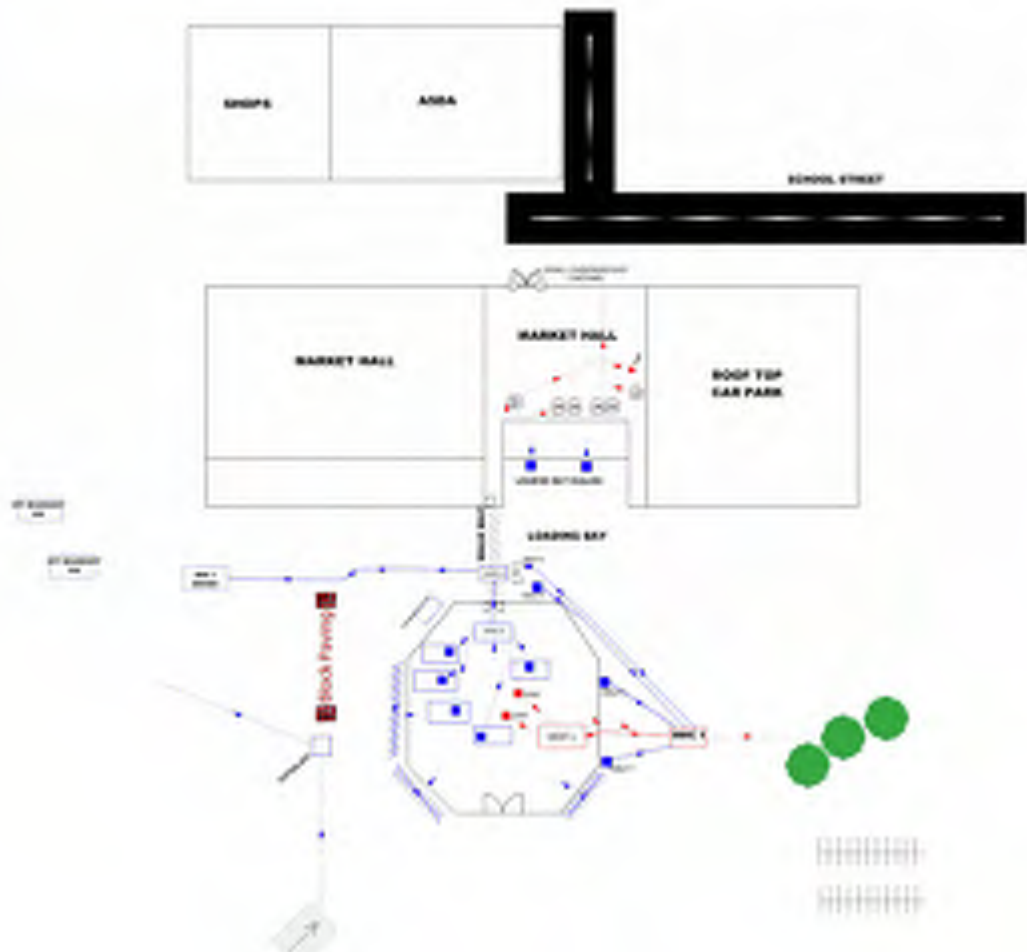
Figure 5: MetroRod CCTV Survey Results Sketch Plan

- 4.7.8 A copy of the CCTV survey results sketch plan is shown in Figure 3 below: a copy of the full CCTV report is enclosed in Appendix B.

This sketch is not to scale and does not represent the exact routing of the drainage system

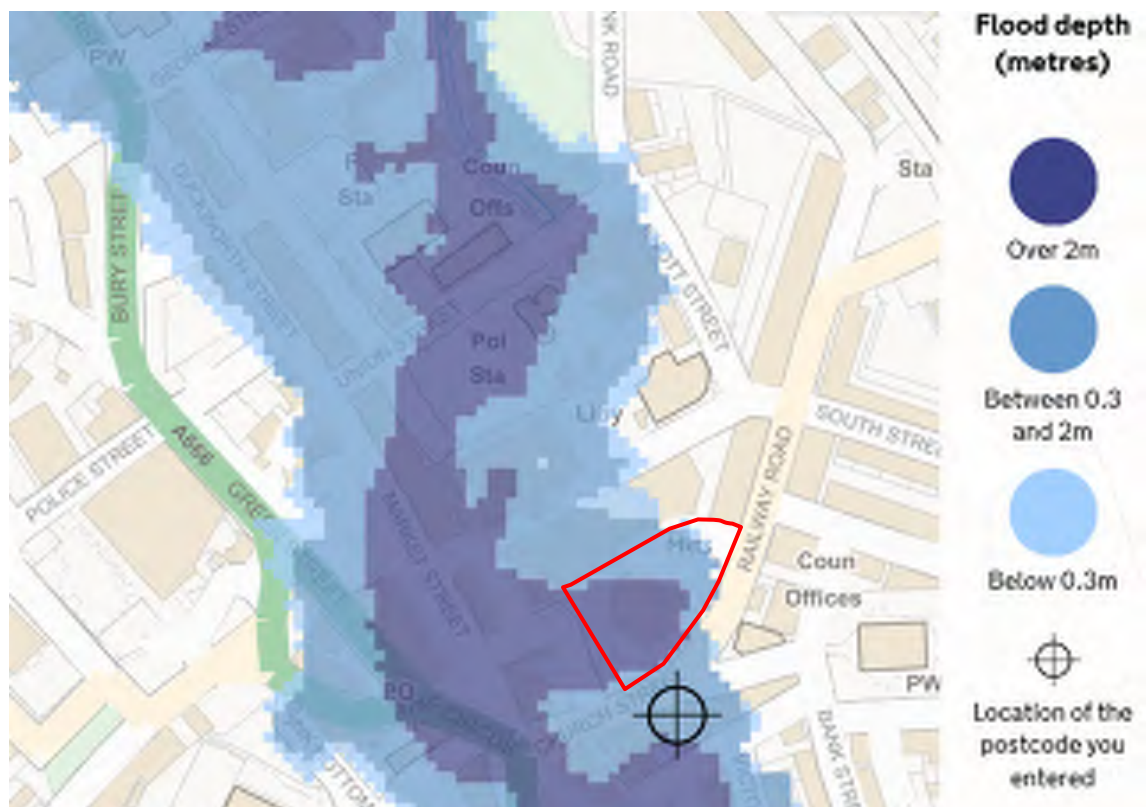
Figure 8: Environment Agency Map (Flood risk from reservoirs – Flood Depth)

- 5.5.1 A review of the Environment Agency: Flood risk from reservoirs shows that the site is at risk of flooding from a failure of the Earnsdale reservoir located 2.1km west of the site. Further, a review of the EA Flood risk from reservoirs - Flood depth map shown in Figure 8 below, shows that the site could be flooded to a depth of over 2m from a failure of the Earnsdale Reservoir.

- 5.5.2 However, a review of the EA Flood risk from reservoirs - Flood speed map shows that the inundation of the site from a failure of the Earnsdale Reservoir will be between 0.5 to 2m/s for the majority of the site. Therefore there should be sufficient time for anyone present on the site at the time of flooding from a failure of the Earnsdale Reservoir to safely egress the site to the adjacent higher ground on Railway Road.
- 5.5.3 Again the proposed demolition of the existing building and conversion to public realm (water compatible development) will help to mitigate the consequence of any reservoir flooding by providing additional flood storage space.
