Harwood St, Darwen

Phase 2 Geo-environmental Investigation & Assessment

G1320-R-01

Harwood Street, Darwen
Phase 2 Geo-environmental Investigation & Assessment

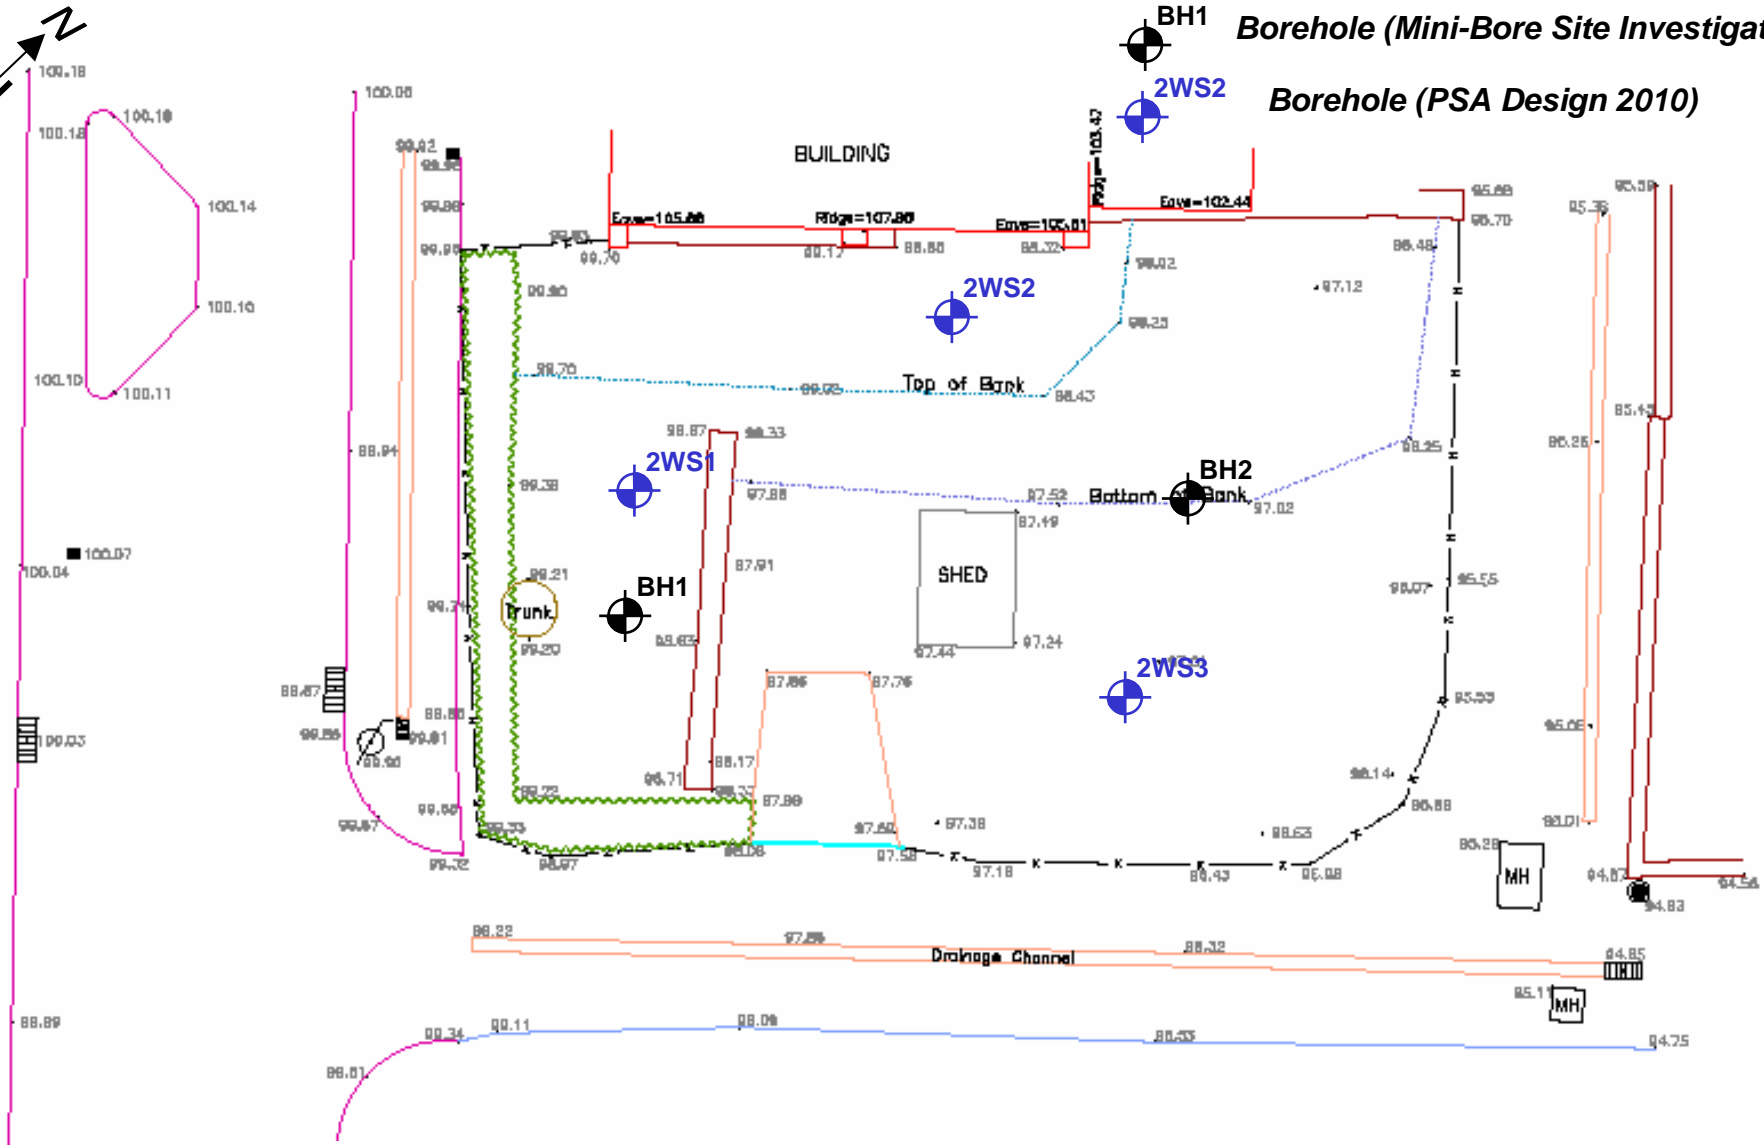
2WS2 Borehole (PSA Design 2010)

Drawing No.	Title
G1320-G-01	Site Location Plan
G1320-G-02	Current Site Features Plan
G1320-G-03	Development Layout Plan
G1320-G-05	Conceptual Site Model
G1320-G-06	Ground Investigation Exploratory Holes Location Plan
